**CONTAMINATION ARISING FROM THIRD-PARTY SOURCES
INDEPENDENT OF MILL & TIMBER PRODUCTS LTD.
10880 DYKE ROAD, SURREY, BC**

Prepared for:
Mill & Timber Products Ltd.

Prepared by:
Envirochem Services Inc.

March 2019

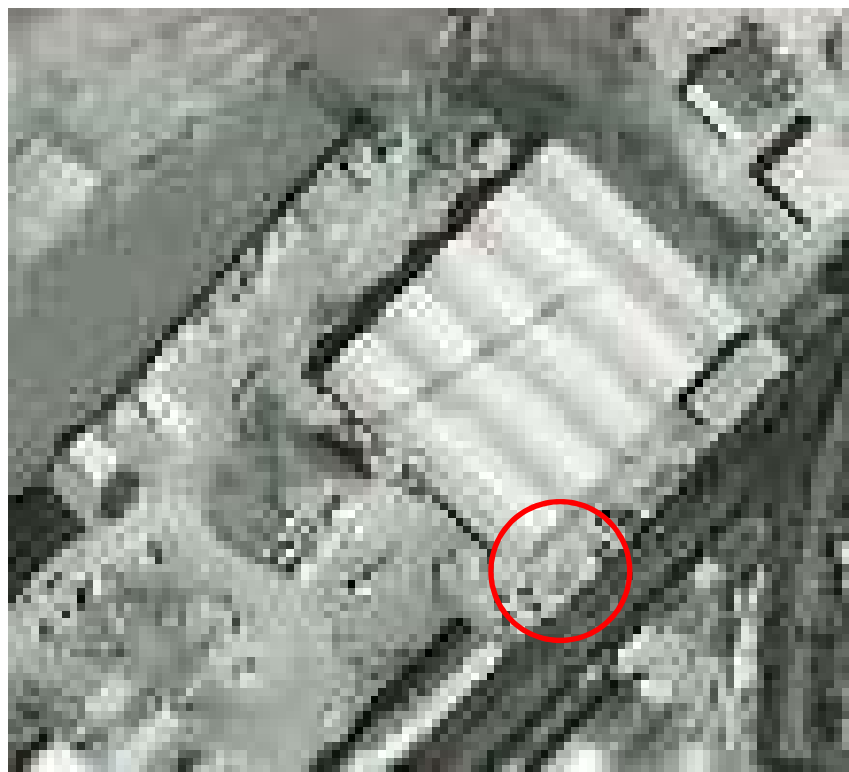
Photo 7 Zoom

Suspect AST no longer present in 1974. Site layout has changed (distribution warehouse has been built).

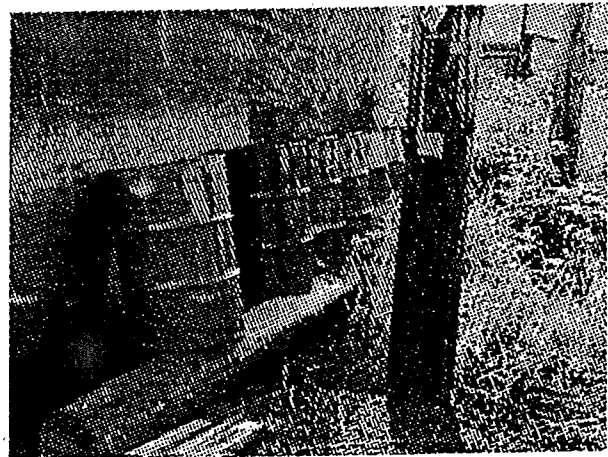
- The oil storage shed was present at that time. Based on the description, it appears to be the same oil storage shed observed later, in 1999, by Envirochem (see section below). Drums of oil and diesel were stored on horizontal cradles inside the shed and were stored upright around the exterior of the shed. Oil-stained wooden floor timbers were observed inside the shed and oil staining was observed on the bare soil near the entrance to the shed (in the southeast section of "Parcel A").

Oil drums stored along south wall of oil shed.

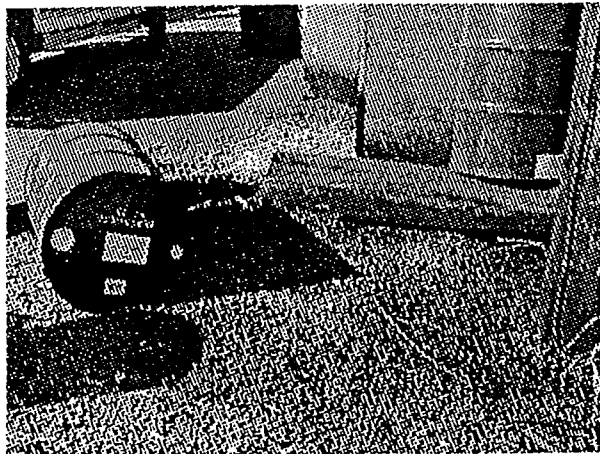
- The oil storage shed was stated as having been in use for at least eight years (c. 1988). Although there are some comments made regarding impacts on "Parcel A", such as "insignificant pockets of hydrocarbon contamination", Mr. Neumeyer made a recommendation for that building to be replaced with a more modern building that would not be prone to oil potentially seeping through the floor and into the ground and to "remediate the underlying soils".

Oil staining of soil near entry door to oil shed

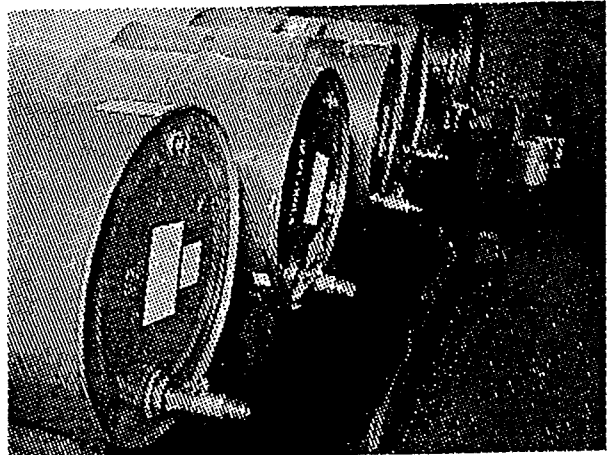
Inside of oil shed showing bulk dispensing drums and drip tray.

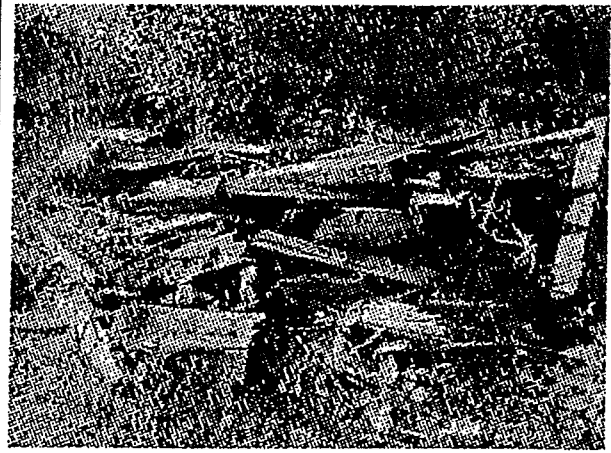
Pile of fire damaged wood demolition debris north of sand piles in Parcel C.

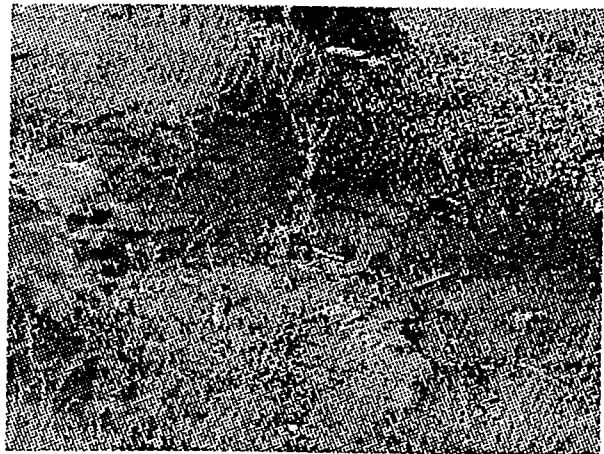
- An area of surficial oil staining was also observed on open ground southwest of several sand piles, which are shown in a figure as being on Parcel Rem-C, northeast of the distribution warehouse building. The exact location of this staining was not referenced, but it is not believed that this refers to any of the areas where hydrocarbon impacts have been previously identified on-Site.

Patch of oily soil between sand piles and paved Lindal storage yard in parcel C.

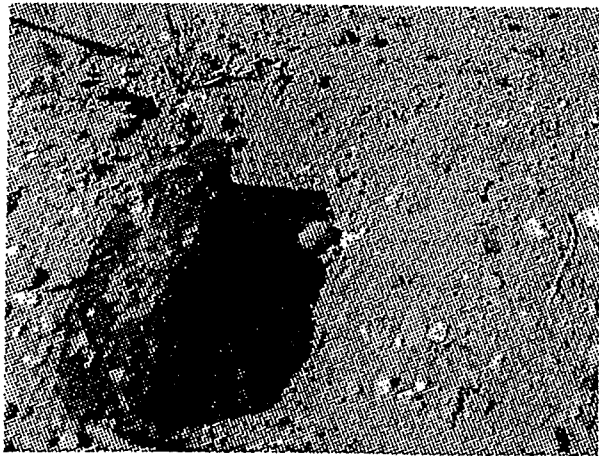
Small piece of asphalt found on top of one of the sand piles.
