JSS LOAD-OUT GRAVEL BED AND EAST INFILL PROJECT

VANCOUVER FRASER PORT AUTHORITY, PROJECT AND ENVIRONMENTAL REVIEW APPLICATION

SUPPLEMENTAL REPORT

JUNE 2020

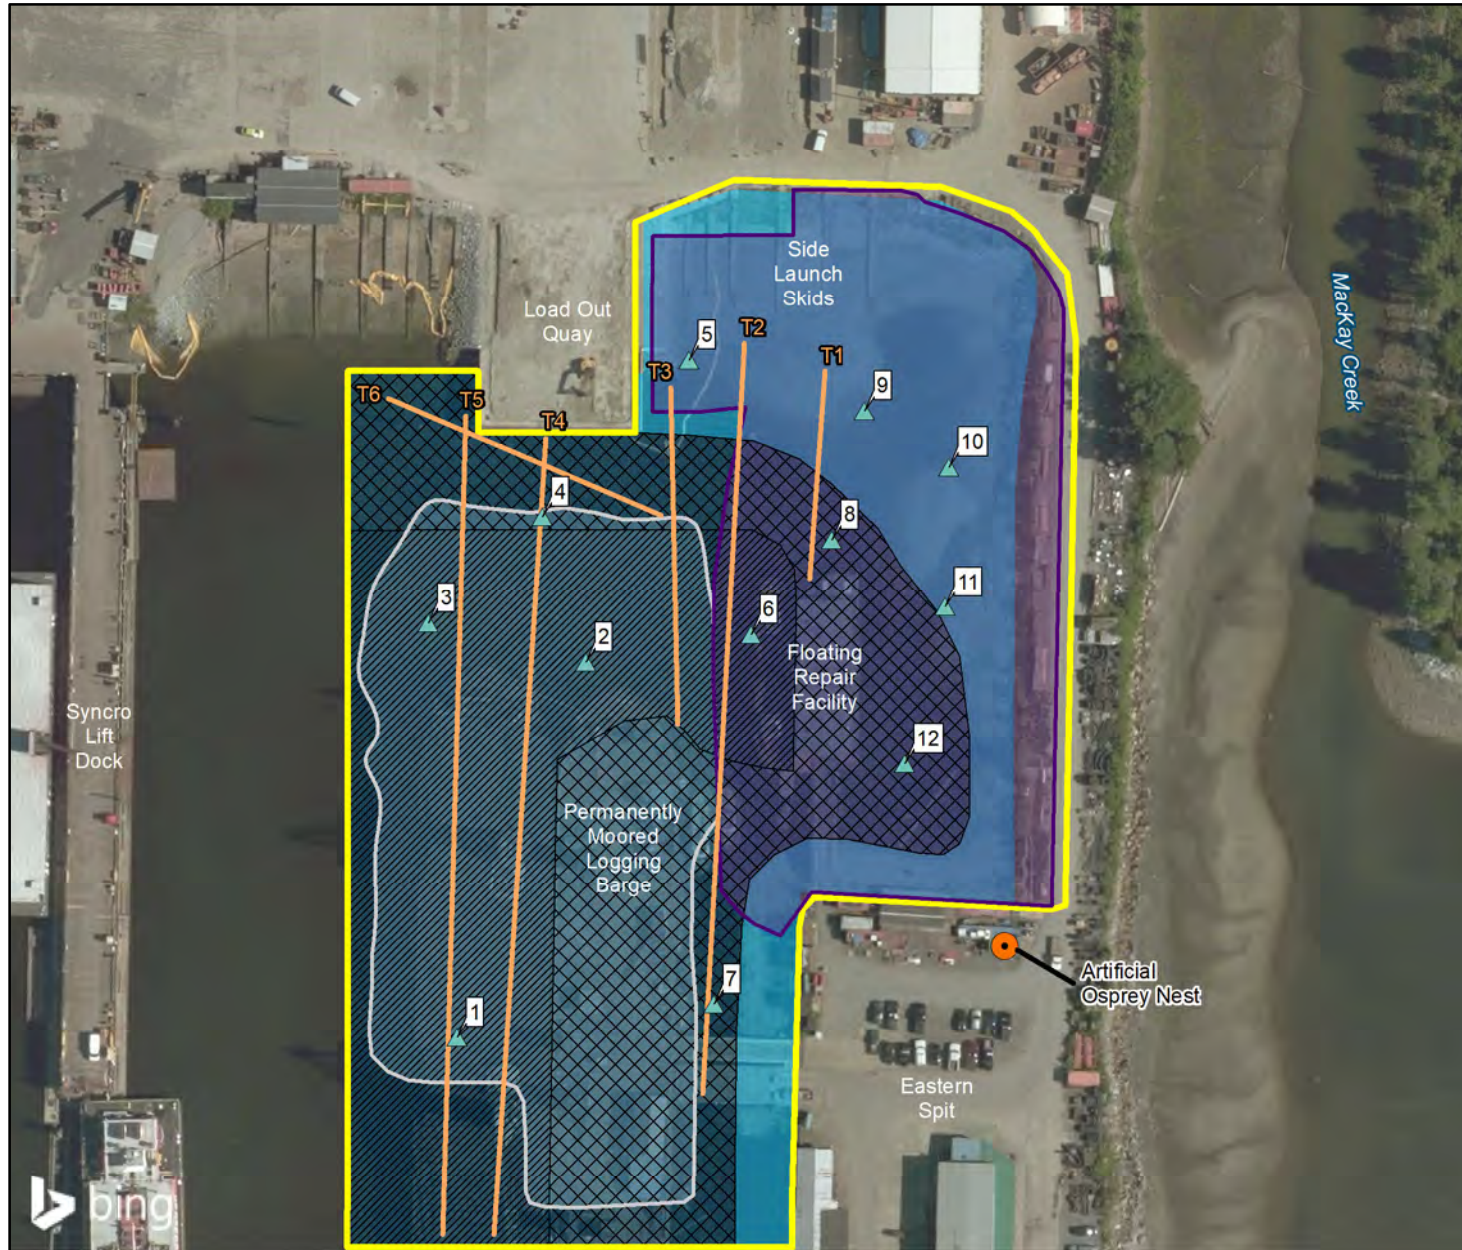
Figure 5-1 Gh Xm5 fYU Zeld k cf _.

- Artificial Osprey Nest
- Field Study**
 - ▲ Sampling Location
 - Transect
 - ▭ Study Area
- Infrastructure**
 - East Infill Footprint
 - JSS Load-Out Gravel Bed Footprint
- Habitat Zones**
 - Intertidal Zone
 - Nearshore Subtidal Zone (Cut Slope)
 - Nearshore Subtidal Zone (Dredge Channel)

Videography transects were taken in a south to north direction around permanent infrastructure, including the floating repair facility and the permanently moored barge. The second barge depicted in Figure 5.1 parallel to the permanent barge was not present during the survey.

What appears to be a dredged navigation channel is present south of the load-out pier (Figure 5.1). The channel extends in a dog-leg fashion west from the floating repair facility past the permanently moored log barge and veers south, running parallel to the log barge until the southern boundary of the Study Area. The channel is used by tug boats to gain access to the floating repair facility. Depths in the channel vary between -6.0 to -8.1 m Chart Datum but are generally uniform without large gradients. The seafloor along the dredged channel is predominantly fines and gravel with finer material such as silts and fine sand identified in the deeper portions of the channel. Transects 4 and 5 were taken along the channel depth and show a higher percentage of gravel and fines in the south and mid portion of the transects with minimal to no boulders present (Table 6.1).

The slopes of the dredge channel separate it from the intertidal area (Figure 5.1). The cut slope also separates the dredge channel from the load-out pier to the north of the Study Area and cuts into the intertidal area north of the floating repair facility. The cut slope is present underneath the length of the permanently moored logging barge. Cut slope depths increase from -6.0 m from the channel to 0 m Chart Datum and are characterized by predominantly gravel substrate, as seen in Transect 2 south portion (Table 6.1).

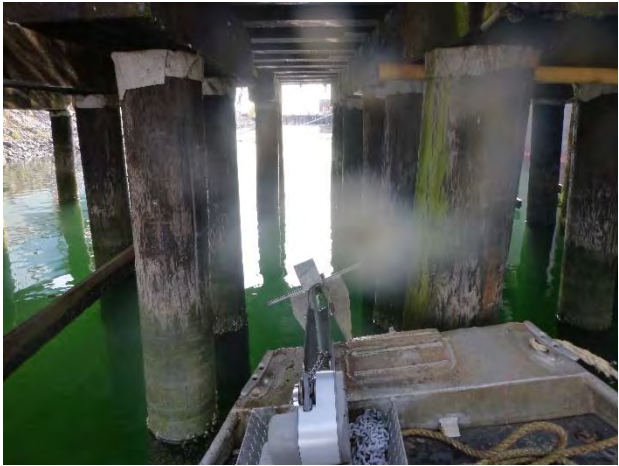
Photo 7 Pier pilons connecting permanently moored barge to eastern spit at start of transect 2

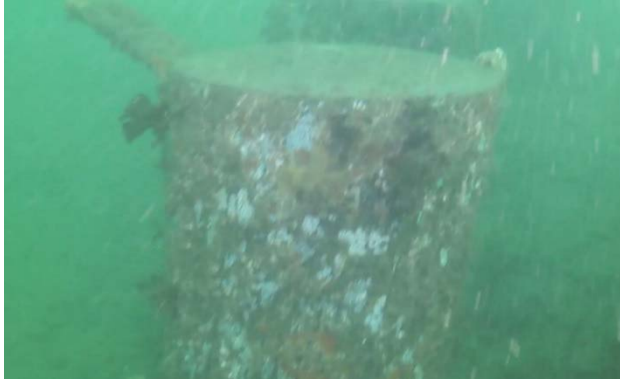
Photo 25 Transect 4 Sawn off pier pylon near endpoint of video survey
