TRANSMITTAL MEMO

CLIENT: VANCOUVER FRAISER PORT AUTHORITY (VFPA)
PROJECT: VFPA FSPL TRANSPORTATION IMPROVEMENTS PROJECT
SUBJECT: RAILWAY CROSSING SAFETY ASSESSMENTS - SUMMARY
DATE: FEBRUARY 9th, 2021

VFPA
REPORT NUMBER: 20-0173

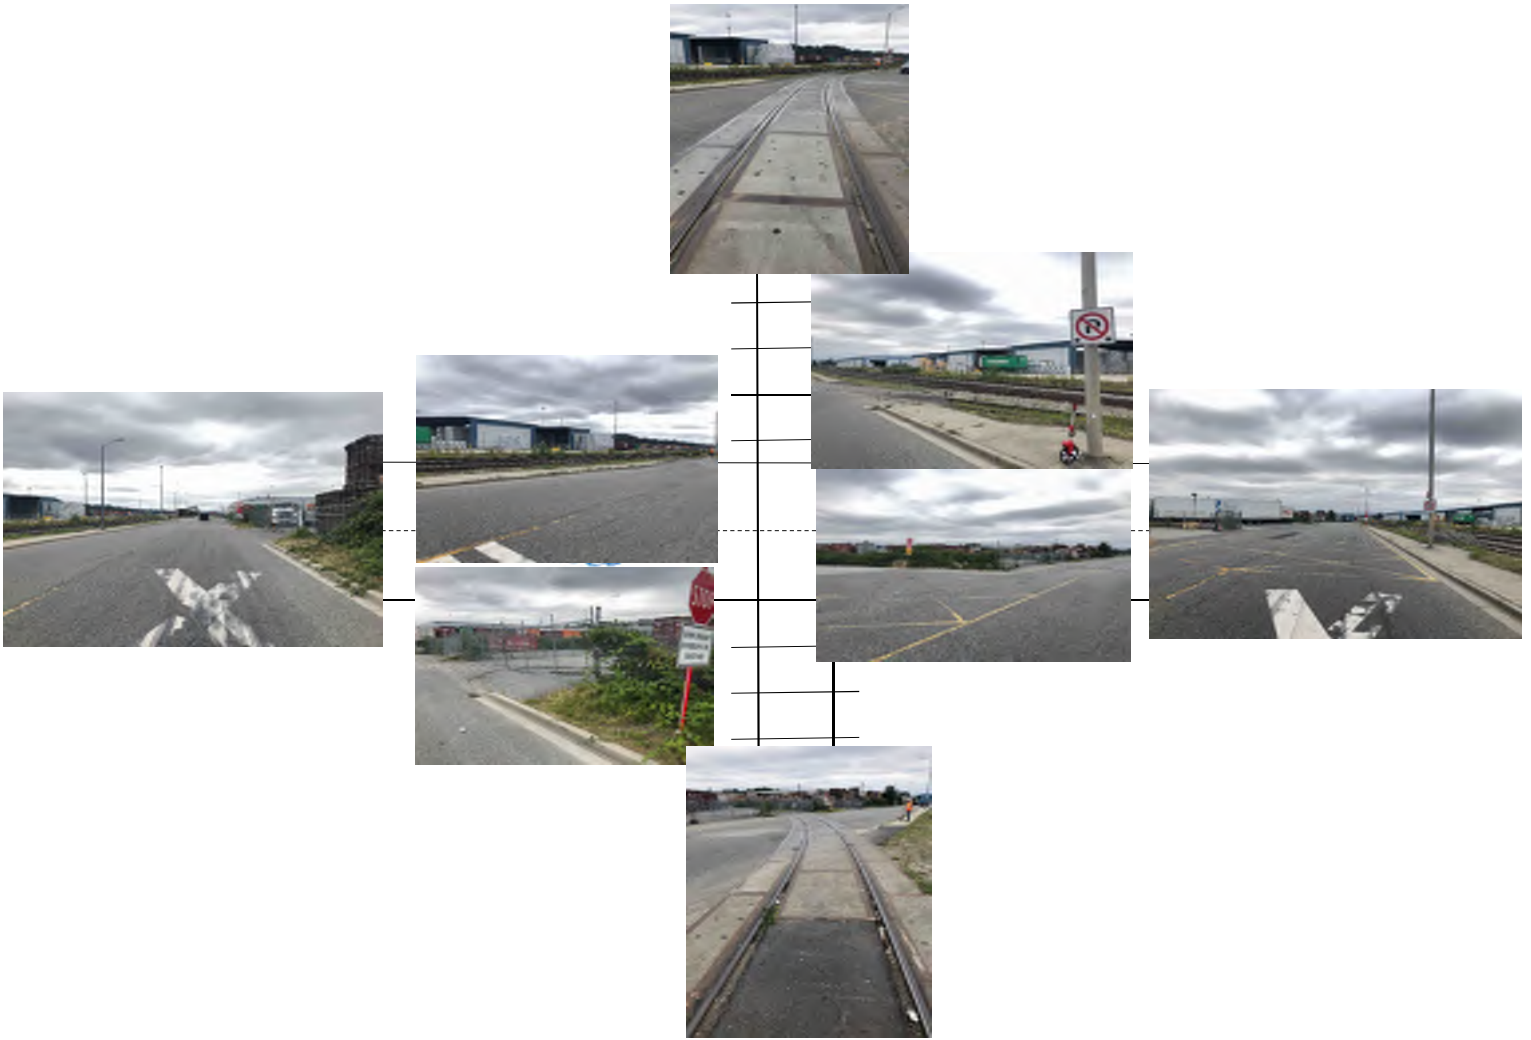
SCENE PHOTOGRAPHS

For the full set of photos taken, see the Appendix to the Safety Assessment Report.
