SEASPAN VANCOUVER DRYDOCK WATER LOT PROJECT HABITAT ASSESSMENT

March 2021

HABITAT ASSESSMENT

SSPAN10806
VERSION 2

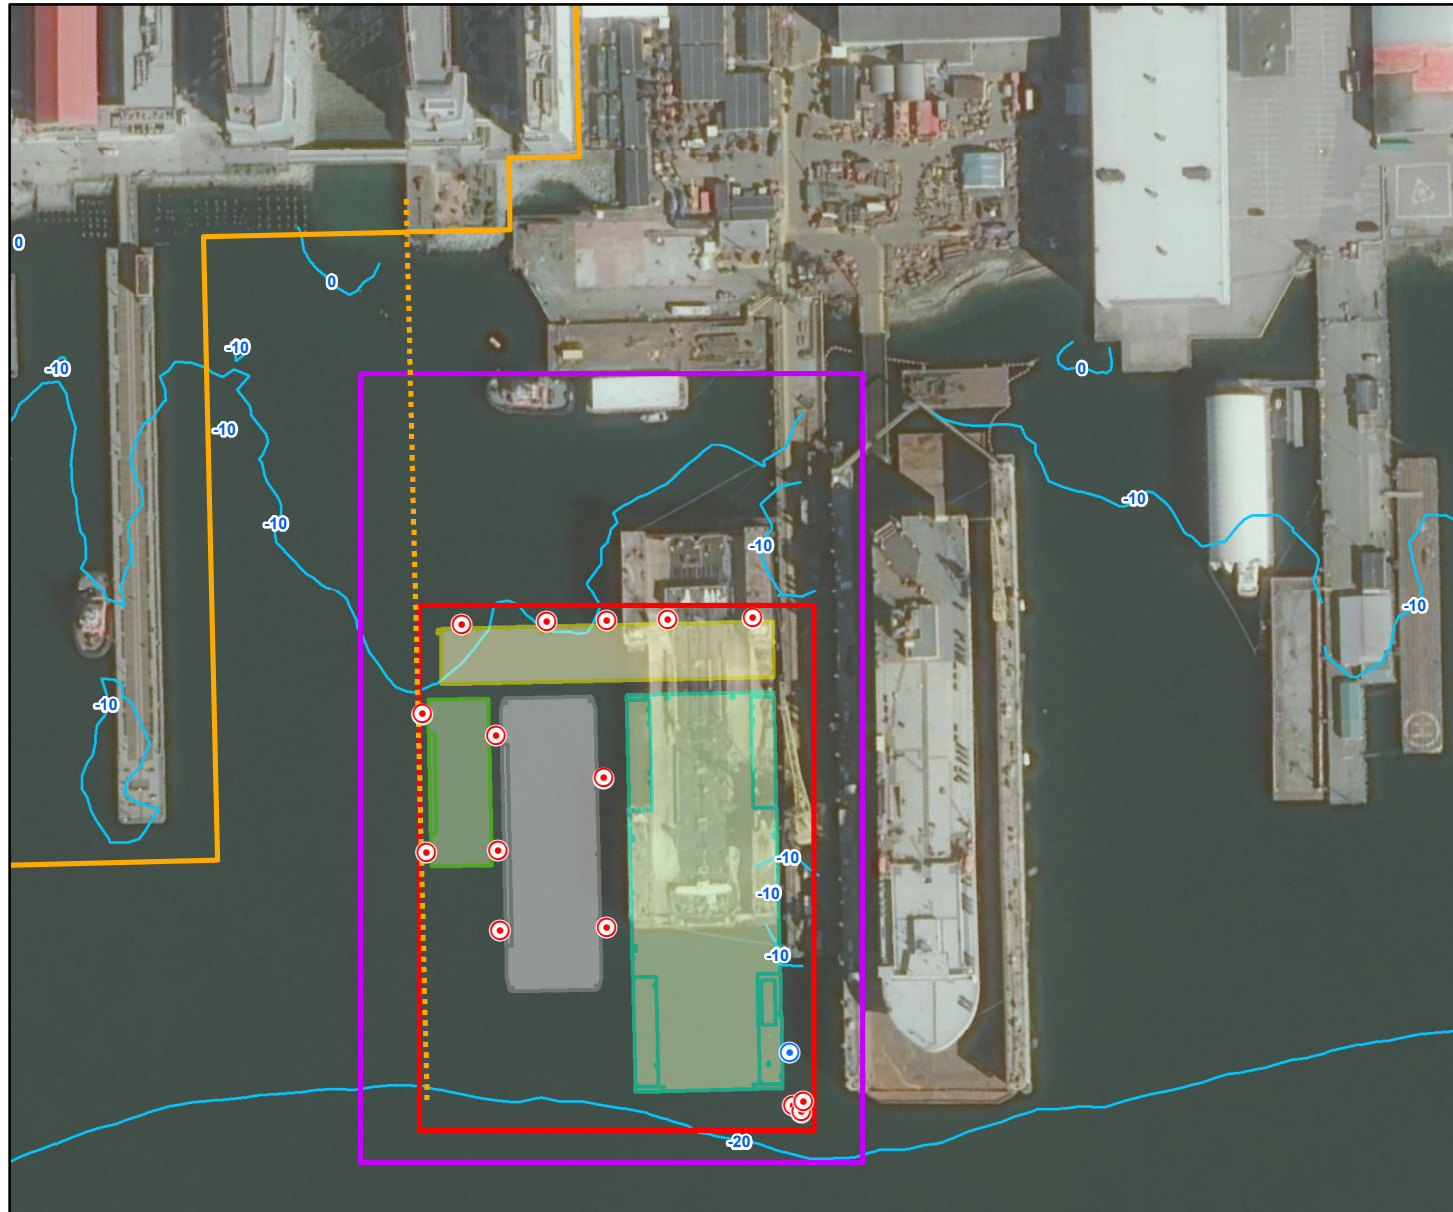
Figure 2 Project Overview.

The Project is located within the Vancouver Fraser Port Authority (VFPA) managed federal lands and waters, along the north shore of the Inner Harbour of Burrard Inlet, at 203 East Esplanade (Figure 2). Within the Study Area, the water depth ranges from about 5 m to 20 m below chart datum (CD; Figure 2; Appendix A2).

A floating work pontoon will be installed on the west side of the deep-water outfitting pier (Figure 2, Appendix A1). This will be used to access the existing Caren and two additional floating drydocks to expand ship repair operations. These structures will be brought in from off site (i.e., they will not be constructed on site). They will be floating and anchored in place by monopiles using primarily 1.2 m diameter steel piles. To make room for the arrangement of the new drydocks, the existing Caren will be moved 60 m to the south and will be anchored in place by a mixture of monopiles and dolphin pile sets. A total of 30 piles will be installed to moor and hold the various floating vessels in position. The piles will be placed in water that ranges in depth from 7 m to 20 m below chart datum as shown in Figure 2. Piles will be driven into the substrate using vibratory hammers and, if necessary, impact hammers. Drilling may be required to advance piles depending on the density of the underlying till in the location of each pile.

The smaller of the two new floating drydocks (Figure 2) measures approximately 55 m in length and is otherwise proportional to its 100 m sister drydock in dimensions. Its capacity is expected to be limited to less than 1,500 tonnes.

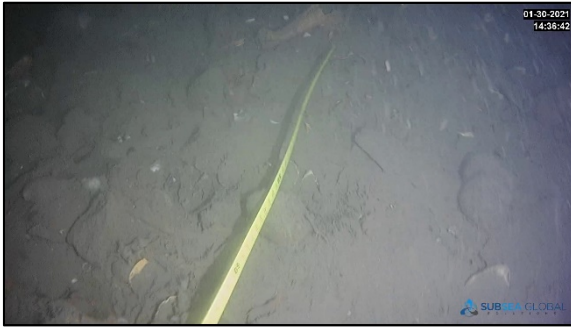
Figure 6 **Representative photos of the four types of substrate in the Study Area.**

Cobble and silt: Cobbles were present in some of the Study Area and were always covered in silt. Photo from T1, under careen.

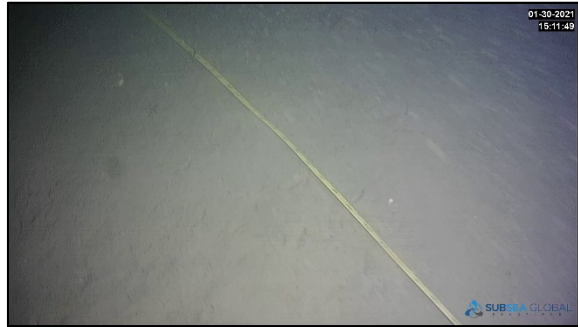
Silt: Silt was the dominant substrate in the Study Area. Photo from T3.
