Sterling Shipyard Remediation and Infill Project

90% Geotechnical Report

Vancouver Fraser Port Authority

October 12, 2021

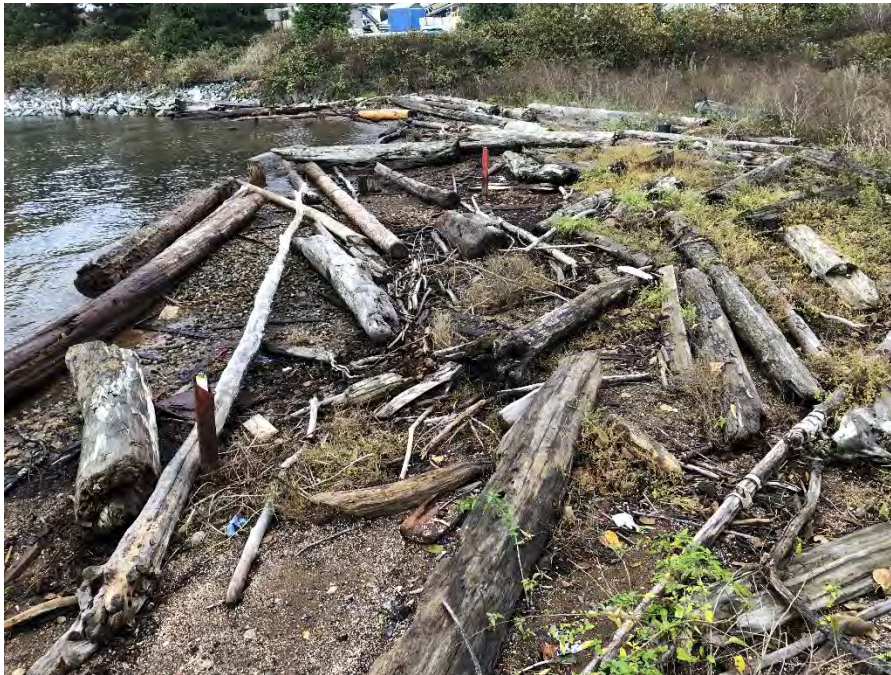
Photograph 3.1: Driftwood accumulation in the foreshore area.

A site visit to review drilling logistics was conducted on October 19, 2020. Personnel representing Blue Max Drilling Inc. (Blue Max) and SNC-Lavalin were in attendance to discuss issues pertinent to the geotechnical investigation, including site access (ramp building), vegetation clearing and tree/driftwood log cutting, general drilling requirements, and proposed borehole locations. Photographs were taken to illustrate site conditions for work plan preparation and permitting requirements. The foreshore area (strewn with driftwood requiring removal and/or cutting) is shown in Photograph 3.1.

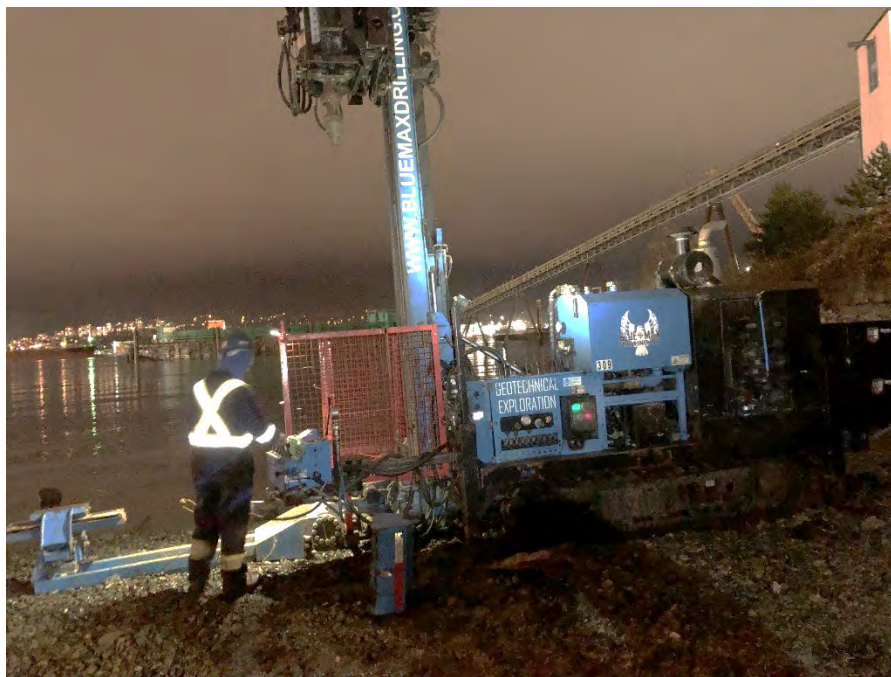
Photograph 3.2: Blue Max track-mounted sonic drill rig used for borehole drilling.

Blue Max completed the drilling of the boreholes utilizing a track-mounted sonic drill rig. Two boreholes were proposed for the field program, with one borehole (BH 20-01) drilled in the central (mid-tide) intertidal area (near the Lafarge property boundary), and one borehole (BH 20-02) at the low tide level to determine subgrade conditions in the area of the seawall. BH20-01 was drilled to a depth of approximately 7.8 m (25.5 ft), while BH20-02 was drilled slightly deeper to approximately 9.1 m (30 ft), where practical refusal was encountered. All drilling was completed in the early morning hours of November 17, 2020. The Blue Max rig used to conduct the drilling is shown in Photograph 3.2.

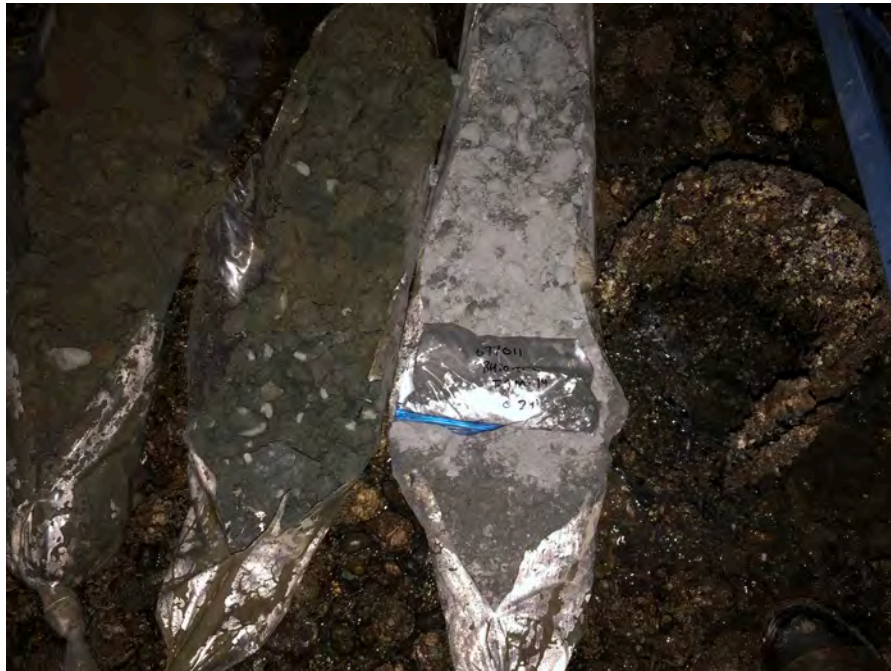
Photograph 4.1: Glacial till core samples.

A very dense glacial till was encountered in both boreholes and formed the base of the investigation. The till matrix was generally well graded, with sub-rounded to sub-angular coarse gravel more frequent with increasing depth. Silt content was variable throughout the unit. Only one sample (IJM-04), which was near the top of the unit, had a higher silt content than sand. The very dense till contact (identified primarily from drill action and sampler refusal) was encountered at depths of approximately 3.0 m (BH20-02) and 4.5 m (BH20-01).

Drilling in this very dense unit was difficult, resulting in slow drill penetration and intense heat generated by the drill bit. SPT penetration was also limited, with split-spoon sampler refusal encountered (with less than 150 mm of penetration) for all tests once completely within the unit, indicating the very high strength and competence of this material. It is noted that the presence of this dense glacial till eliminated the possibility of using conventional sheet-pile installation methods as penetration into this material with vibration or impact hammers is considered unfeasible. Returned cores from the drilling can be seen in Photograph 4.1.

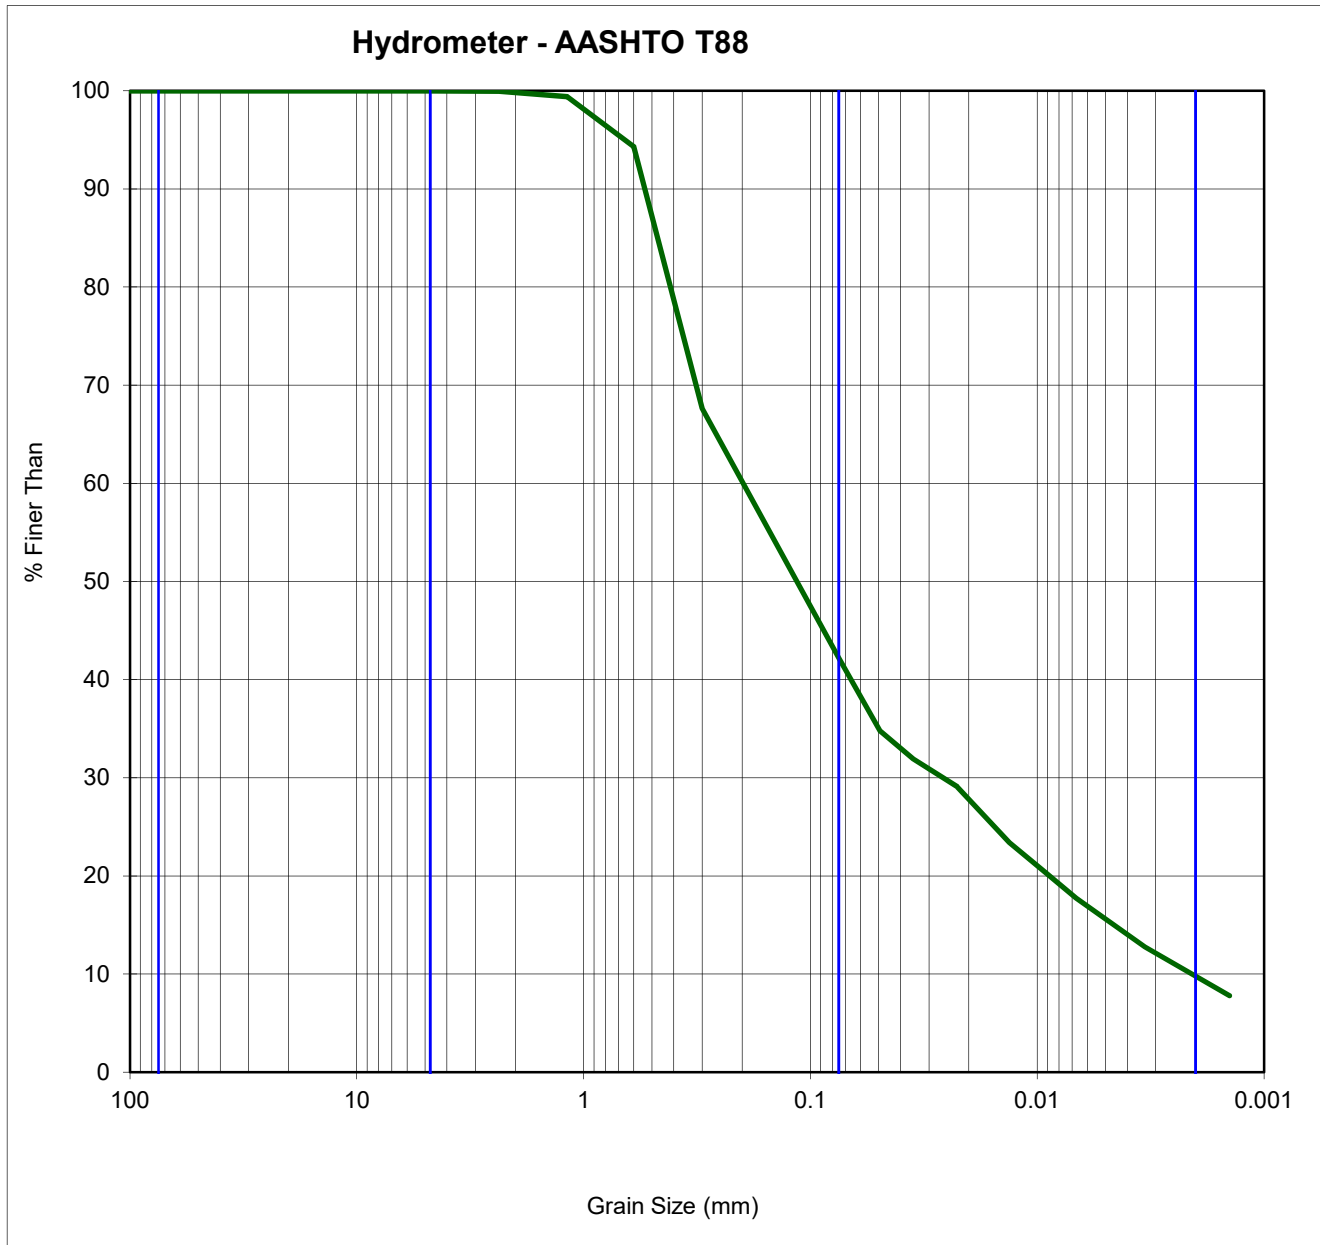
Sample No. IJM06	Date Sampled 16-Nov-20	By IM	of SNC-Lavalin Inc.
Borehole No. BH20-01	Sample Depth (m) 7.32	Natural Moisture 12.2%	
Project No. 677011	Tech. MK/DY

Gravel = **0.0%** Sand = **57.7%** Silt = **33.0%** Clay = **9.3%**

Hydrometer Classification: **Sand, silty, trace clay.**
