# TECHNICAL MEMO

<b>To</b> Sat Oberoi, Design Build Manager Ledcor Group	<b>From</b> Emilia Cronin, Environmental Specialist Langley Branch
<b>Re</b> Portside Blundell Road Improvements Biophysical Overview Assessment	<b>Date</b> May 30, 2022

The Portside Overpass / Blundell Widening Project (the Project) is part of the Portside Blundell Road Improvements (PBRI), a package of road and rail infrastructure upgrades that are part of the wider Greater Vancouver Gateway (GVG) program currently being delivered by Vancouver Fraser Port Authority (VFPA). VFPA is seeking to upgrade the transportation corridor adjacent to the marine terminals on the lower Fraser River in Richmond, BC (Figure 1), to improve travel safety and efficiency near the existing railway crossing. The initial phase of this work extends from No. 8 Road west towards the No. 7 Canal and includes both Portside and Blundell Road. Planned improvements include railway upgrades and road improvements, and installation of road-railway grade separations.

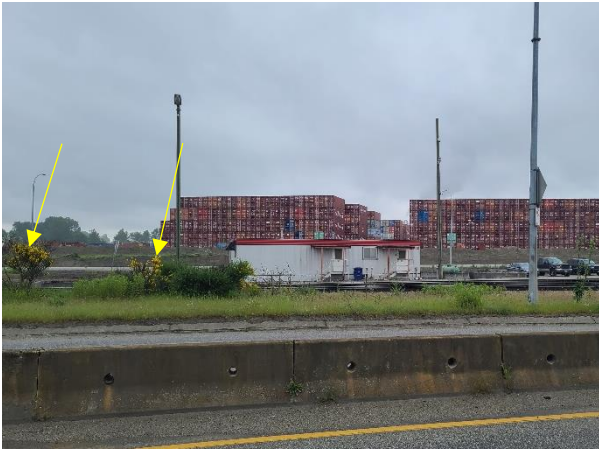
**Photograph 1.** View south across Blundell Road. Scotch broom within the CN Rail verge is identified in yellow. The sandy edge of Portside Road is visible in the background.

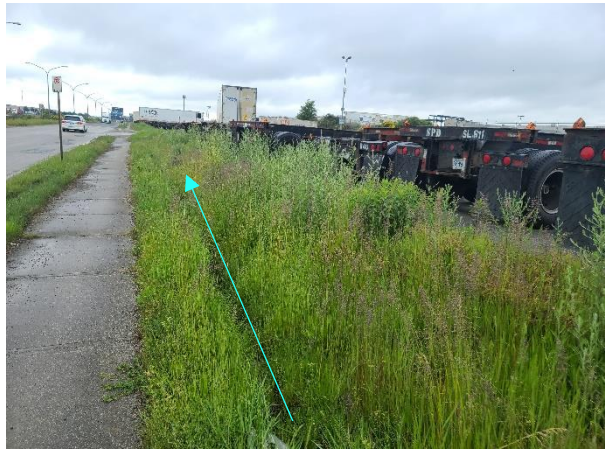
**Photograph 2.** View west along the north side of Blundell Road, illustrating the herbaceous species present. Many of these species are non-native. The ephemeral ditch is identified in blue.

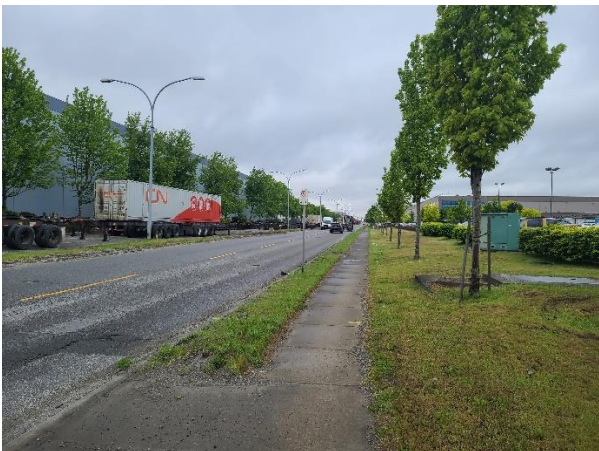
**Photograph 3.** View west of the treed edges of Blundell Road. Many of these trees are bylaw sized. No nests were observed at the time of survey.

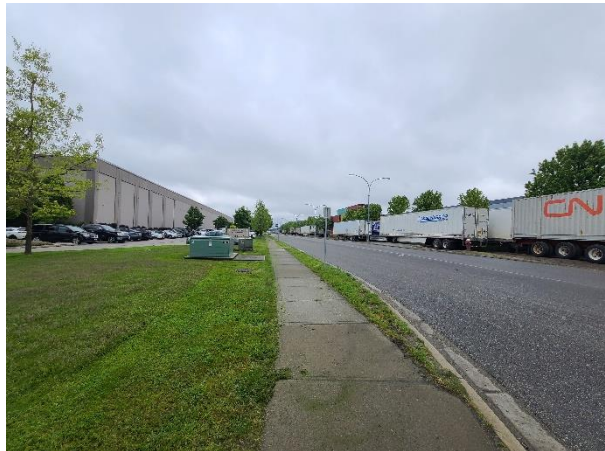
**Photograph 4.** View west of the landscaped edges of Blundell Road. No wildlife were noted.

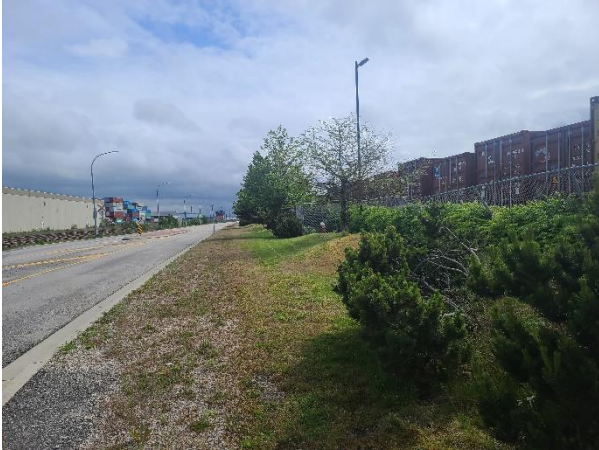
**Photograph 5.** View east along the south side of Portside Road, illustrating the condition of the landscaped vegetation.

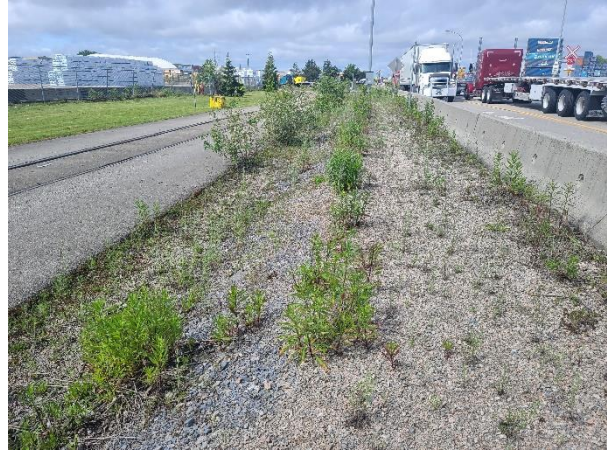
**Photograph 6.** View west along the south side of Portside Road, illustrating sparse vegetation in this disturbed area.

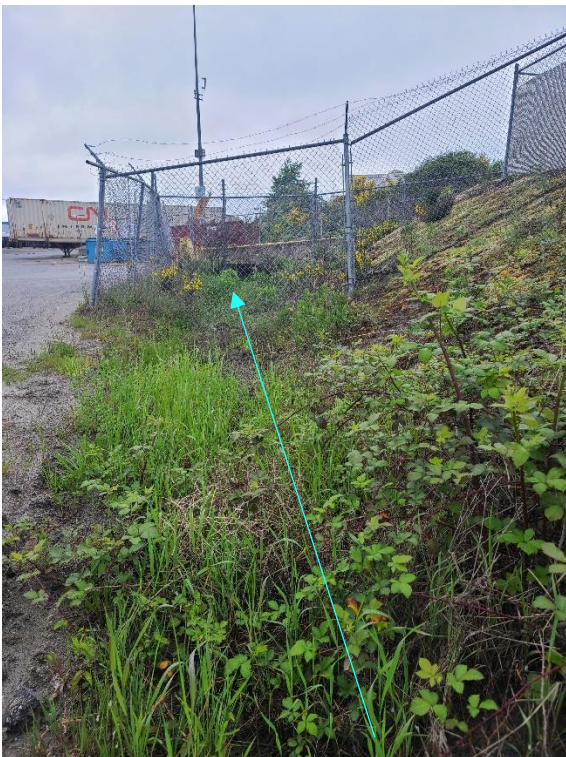
**Photograph 7.** View west along the ditch and berm at the north side of the Impact Auto Auctions parking lot. No signs of flow were observed. Blackberry is common in this area.

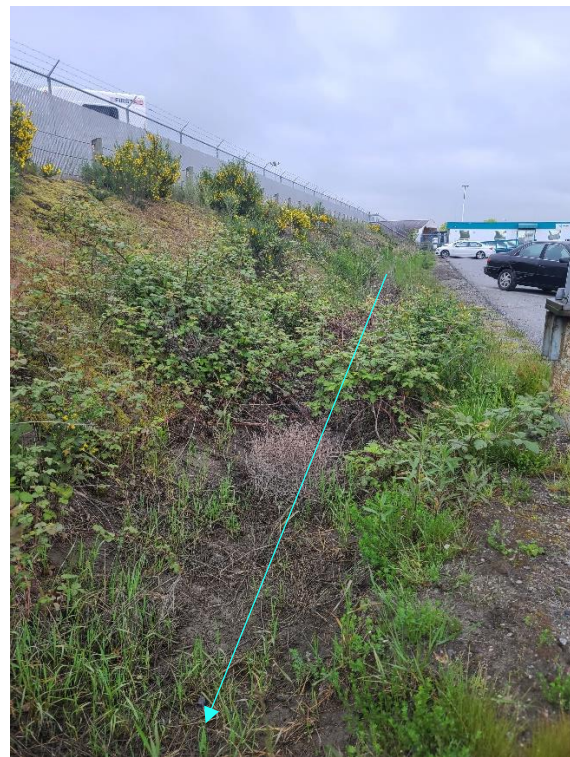
**Photograph 8.** View east along the ditch and berm at the north side of the Impact Auto Auctions parking lot. No signs of flow were observed. Blackberry and Scotch broom are apparent.

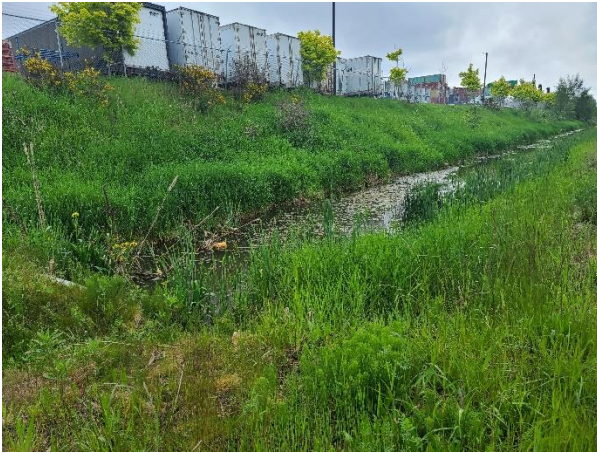
**Photograph 9.** View south along the ditch east of the No. 7 Canal. This riparian area is outside of the project construction footprint, but is likely connected via stormwater drainage.

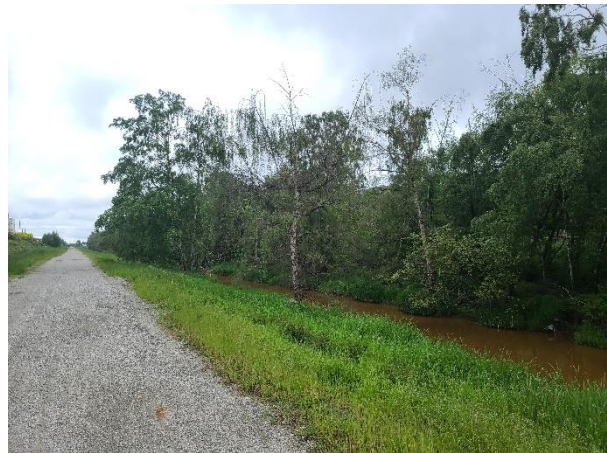
**Photograph 10.** View south along the No. 7 Canal. This riparian area is outside of the project construction footprint, but is likely connected via stormwater drainage.

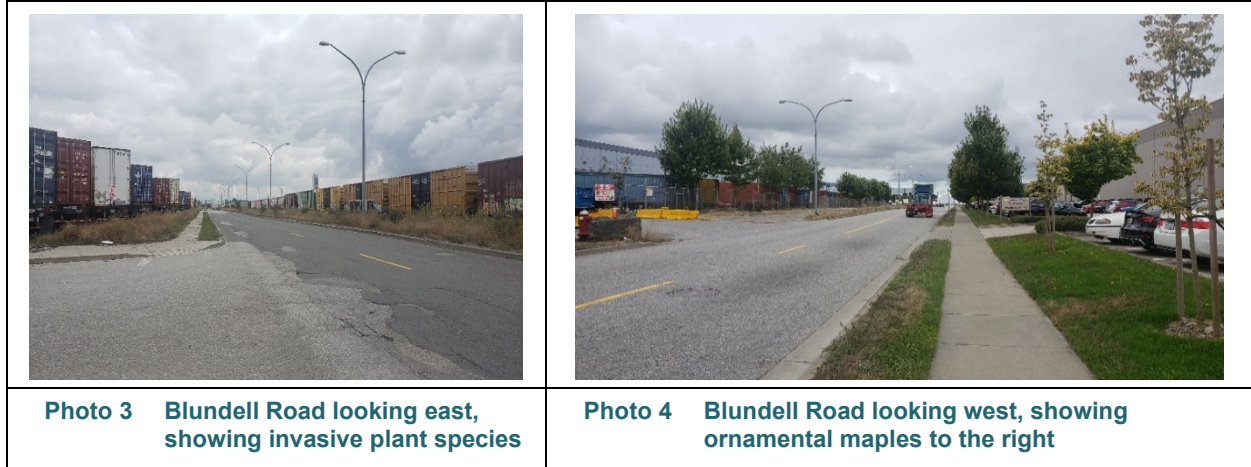
<p><b>Photo 1</b> Blundell Road looking east, road widening expected to occur to right of existing road</p>	<p><b>Photo 2</b> Blundell Road looking east, showing ornamental cherry trees to the left</p>

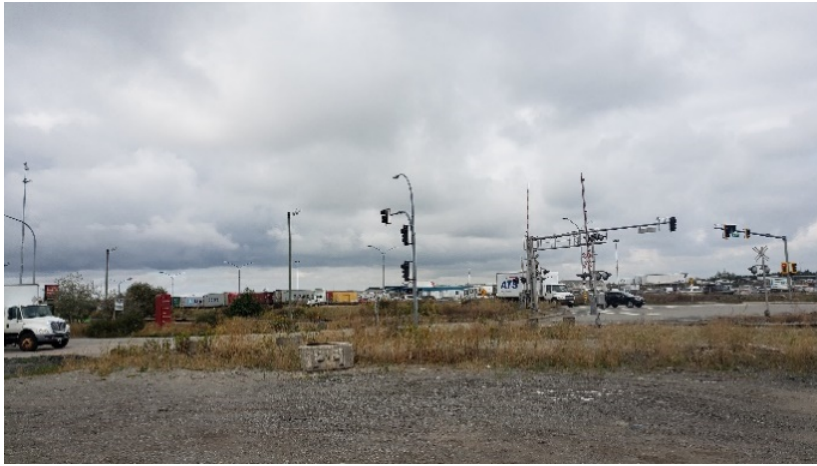
**Photo 5** Intersection at Portside Road and No. 8 Road, looking northwest

The Portside Overpass component of the LSA consisted of landscaped areas with ornamental species, and grassy segments interspersed with some native and invasive plants (Photos 5 to 12). The manicured grounds at the port entrance occupied an area of approximately 450 m<sup>2</sup> and included a patch of planted Pacific ninebark (*Physocarpus capitatus*), two patches of nootka rose (*Rosa nutkana*), and the following non-native species: willows (*Salix sp.*), aloe (*Aloe sp.*), mountain pine (*Pinus mugo*), and orpine (*Hylotelephium telephium*). There is evidence of mowing, but the area appears to be irregularly maintained.

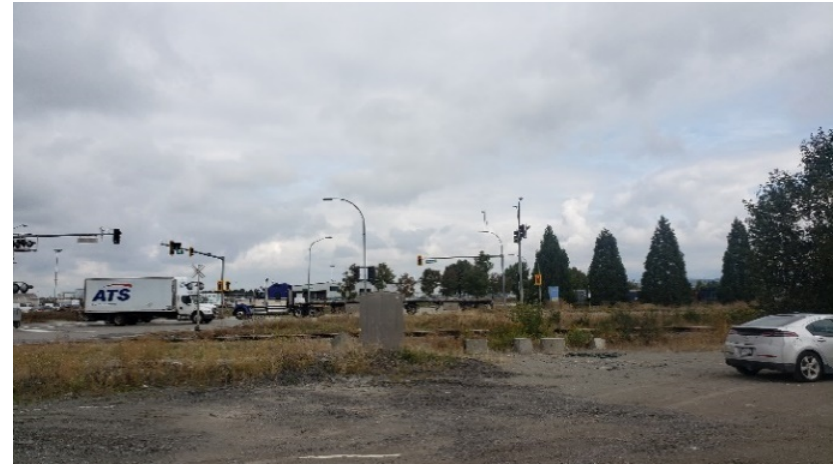
**Photo 6** Intersection at Portside Road and No. 8 Road, looking west and showing hybrid cedars

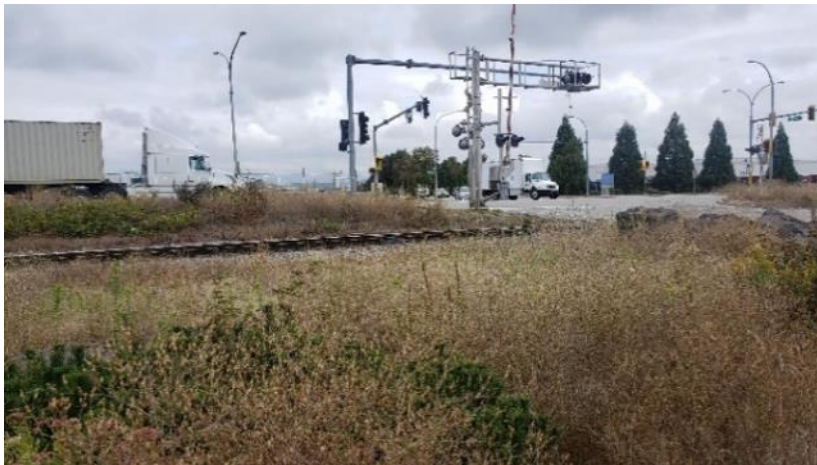
**Photo 7** Blundell Road/Portside Road intersection, looking northeast from landscaped area at Port entrance

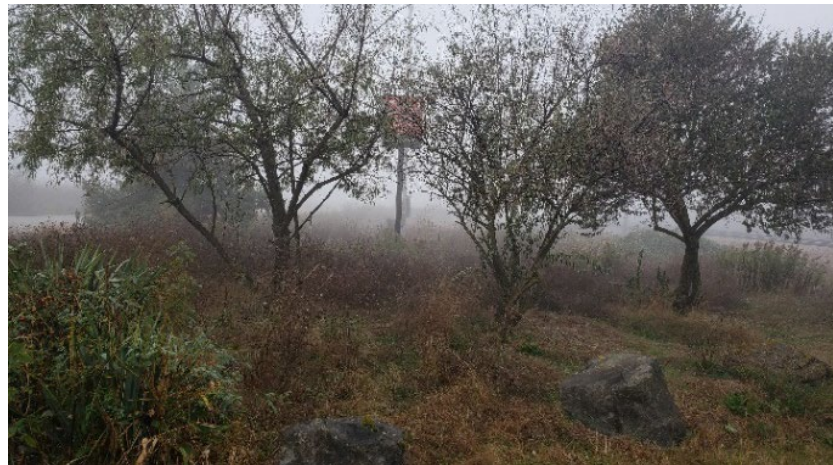
**Photo 8** Landscaped area near Port entrance on Portside Road, showing willow trees and nootka rose bushes

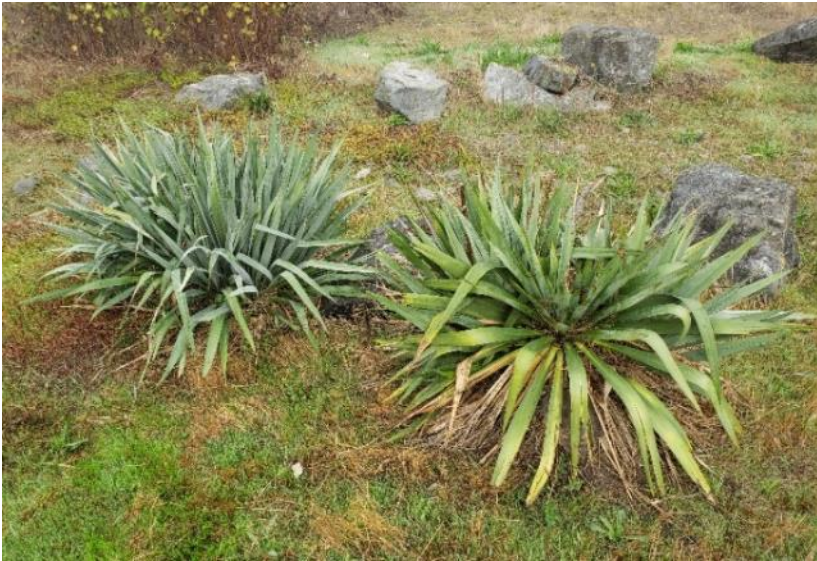
Photo 9 Aloe species seen in landscaped area at Port entrance

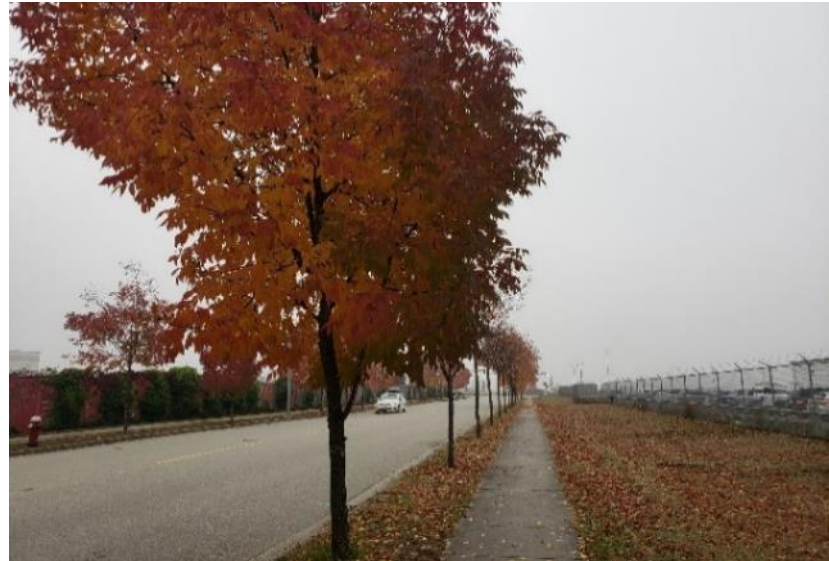
Photo 10 Unknown tree species along No. 8 Road north of Blundell Road

Twenty-six ornamental and non-native trees (unknown species) lined the west and east sides of No. 8 Road, to a distance of 150 m north of the proposed overpass location (Photo 10). The trees were 5 m to 8 m tall and approximately 10 cm in DBH. Five 10 m-tall hybrid cedar trees were present at the north east corner of Blundell Road and No. 8 Road. Two black cottonwood trees were present south of the CN trail tracks at this location, both approximately 10 m tall and 10 to 12 cm in DBH. Black cottonwood saplings were scattered throughout the Portside Overpass portion of the LSA, as were grassy areas with interspersed patches of Canada goldenrod.

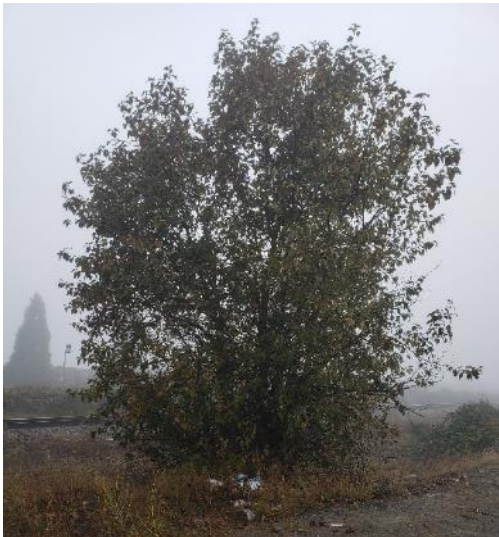
Photo 11 Black cottonwood tree south of proposed overpass

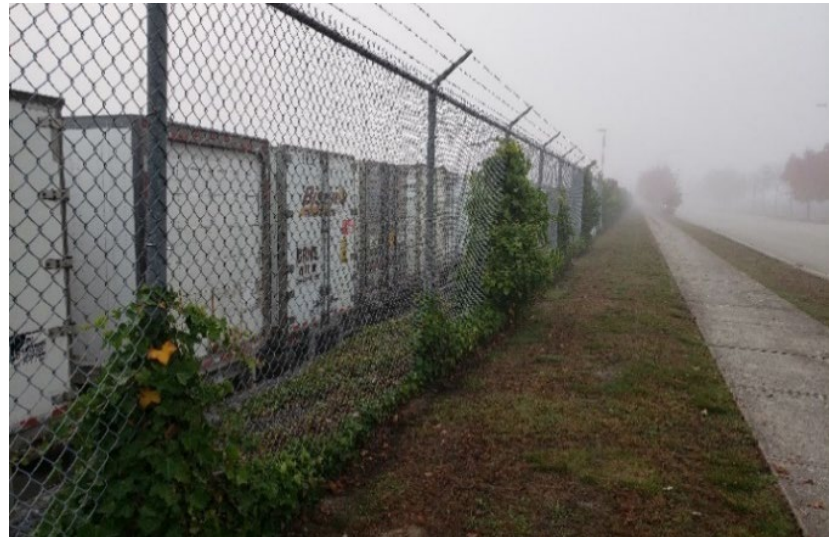
Photo 12 English ivy growing on fence along No. 8 Road

The western half of the Blundell Road portion of the study area contained Himalayan blackberry (*Rubus armeniacus*) patches, particularly on the south side of the road. The grassy segments further east on Blundell Road contained Himalayan blackberry (*Rubus armeniacus*) patches and scattered Scotch broom (*Cytisus scoparius*) plants. Another prevalent invasive plant species observed in the Portside Overpass portion of the LSA was common tansy (*Tanacetum vulgare*). English ivy (*Hedera helix*) was observed lining a fence at No. 8 Road (Photo 12).

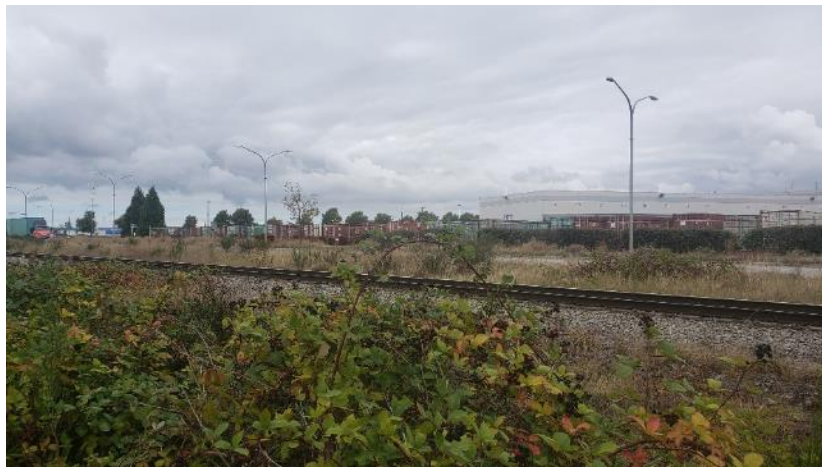
Photo 13 Ditch along the CN rail tracks, showing Himalayan blackberry

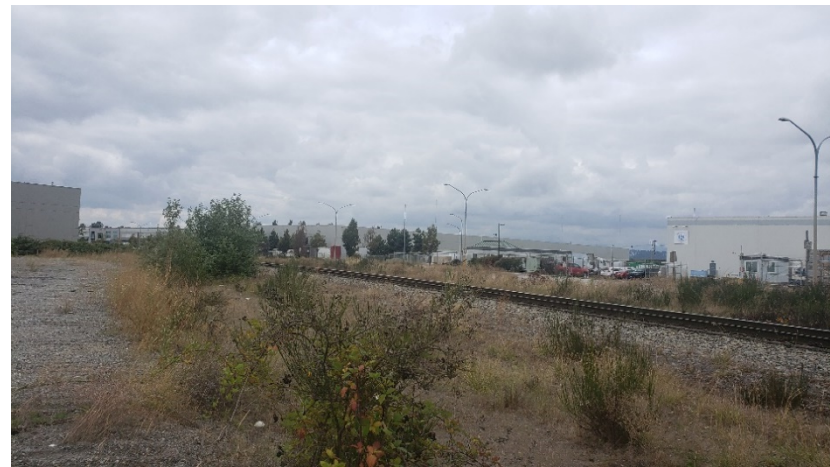
Photo 14 Ditch along the CN rail tracks, showing Scotch broom

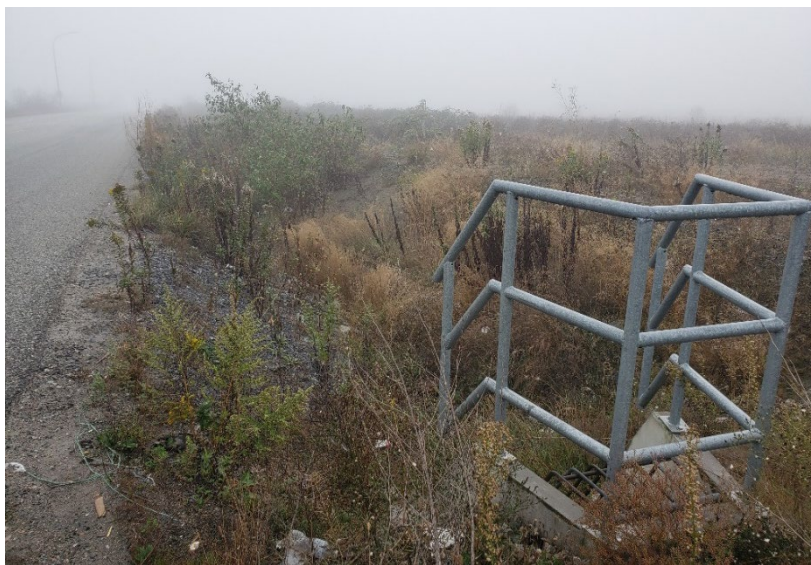
Photo 15 Ditch connecting to culvert along Portside Road
