FRASER SURREY PORT LAND – TRANSPORTATION IMPROVEMENTS BIOPHYSICAL SURVEY AND ASSESSMENT REPORT

FRASER SURREY PORT LANDS – TRANSPORTATION IMPROVEMENTS BIOPHYSICAL SURVEY AND ASSESSMENT REPORT

VANCOUVER FRASER PORT AUTHORITY

PROJECT NO.: 20M-00758-00
CLIENT REF:#20-0173
DATE: MAY 17, 2021

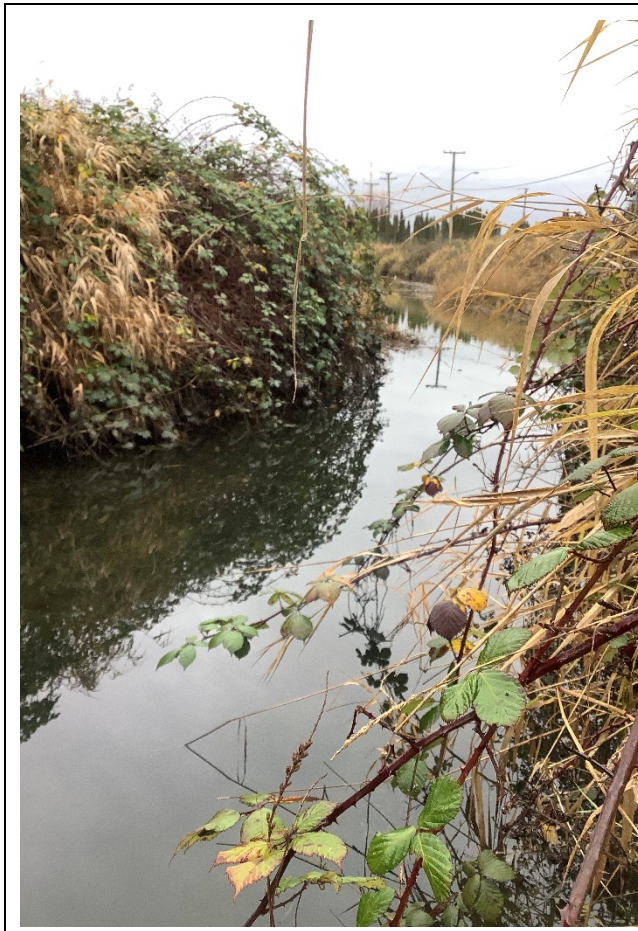
The creek channel width is 5.0 m wide, the wetted width is 3.5 m wide and the water depth was 0.90 m. Dominant substrate was cobbles and subdominant was fines. The dominant cover for fish was overhanging vegetation and the water depth. The banks were sloped and composed of fines and rip-rap. Riparian vegetation consisted of shrubs and grasses with Himalayan Blackberry on both sides (Photo 3, Photo 4).

Photo 3: Site 2, Shadow Brook looking downstream (west) towards Gunderson Slough.

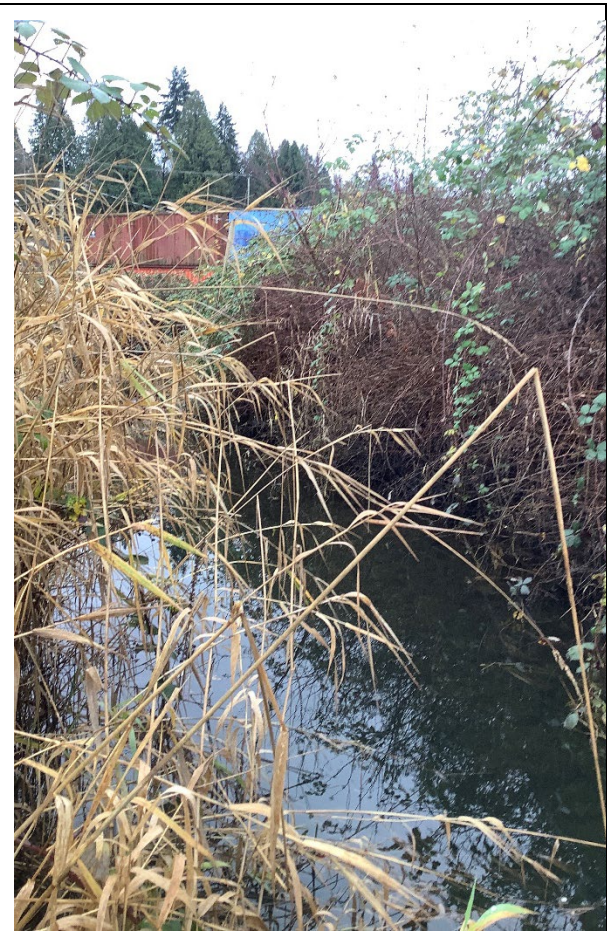
Photo 4: Site 2, Shadow Brook looking upstream (east) towards Gunderson Road.

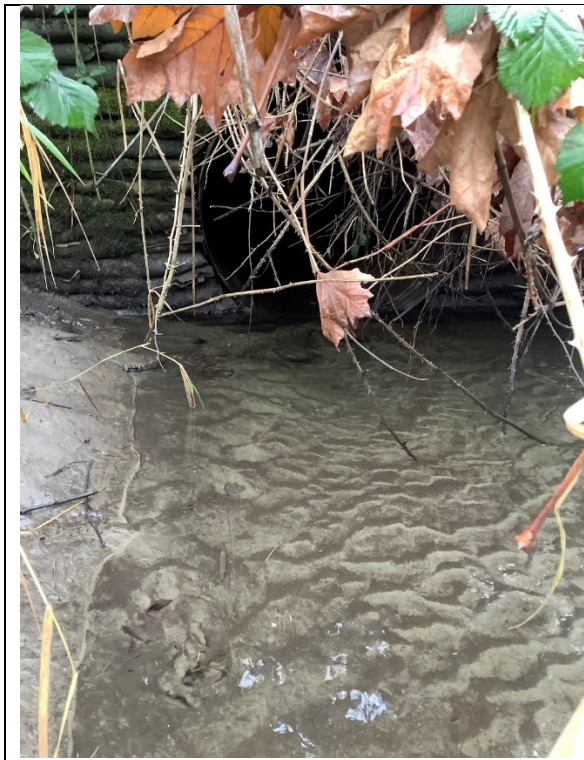
The channel is approximately 1.5 m wide, the wetted width is 1.72 m and the depth was 0.25 m. Dominant substrate was fines and subdominant was gravels. The dominant cover for fish was overhanging vegetation. The banks were undercut or sloped and composed of fines. Riparian vegetation was mostly grass and shrubs including Himalayan blackberry.

Photo 5: Site 3 Unnamed Creek, looking downstream (south) at culvert that flows into Shadow Creek.

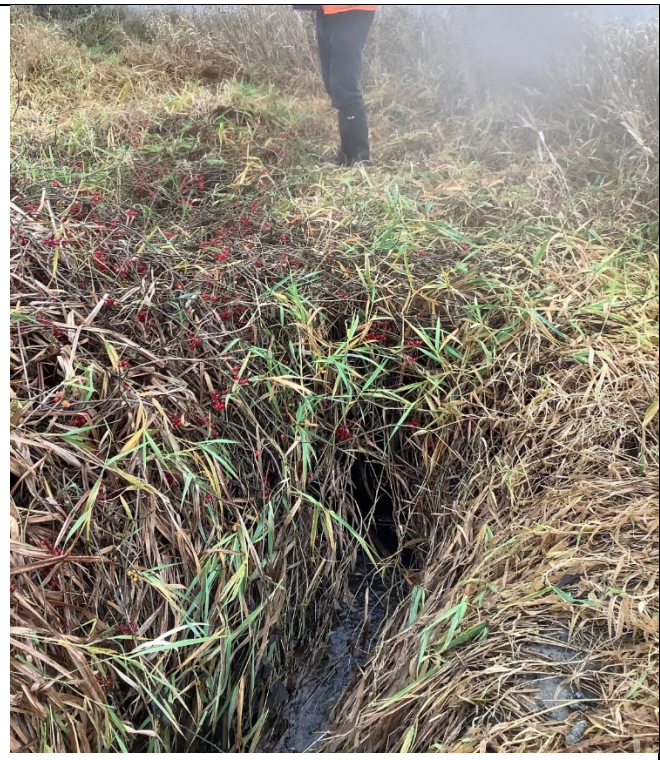
Photo 6: Site 3 Unnamed Creek looking upstream (east) towards culvert under Robson Road.

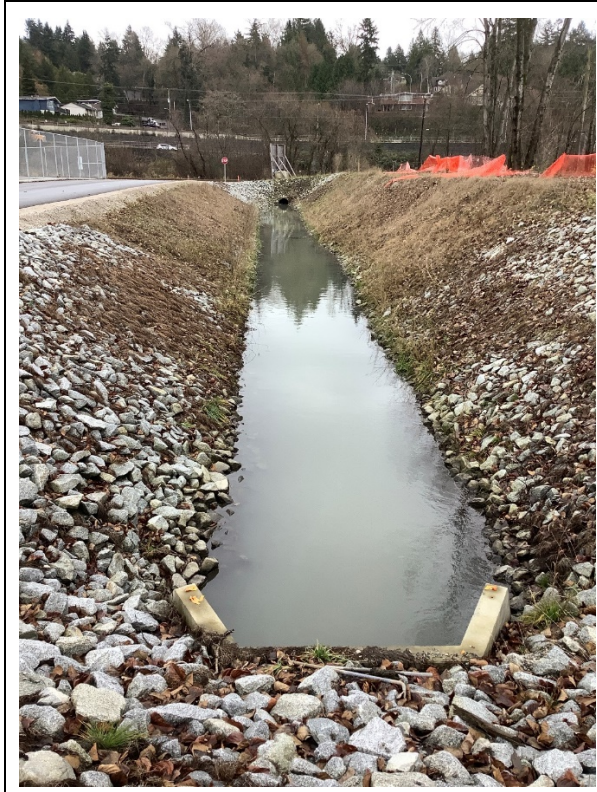
The channel width and wetted width was similar due to the absence of natural banks characteristics and were approximately 3.6 m wide. The average channel depth was 0.30 m. The dominant substrate was fines with cobbles (likely rip-rap). The dominant cover for fish if accessible is cobbles and the turbidity of the water. The banks are sloped with rip-rap. The vegetation for the banks is beginning to grow with grasses.

Photo 7: Site 4, drainage ditch looking east towards Robson Road.

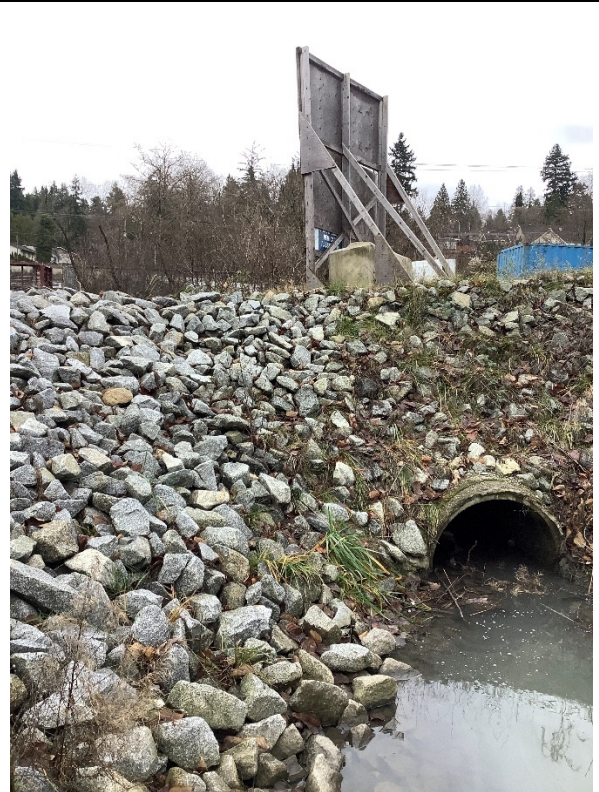
Photo 8: Site 4, looking at concrete culvert under Robson Road.

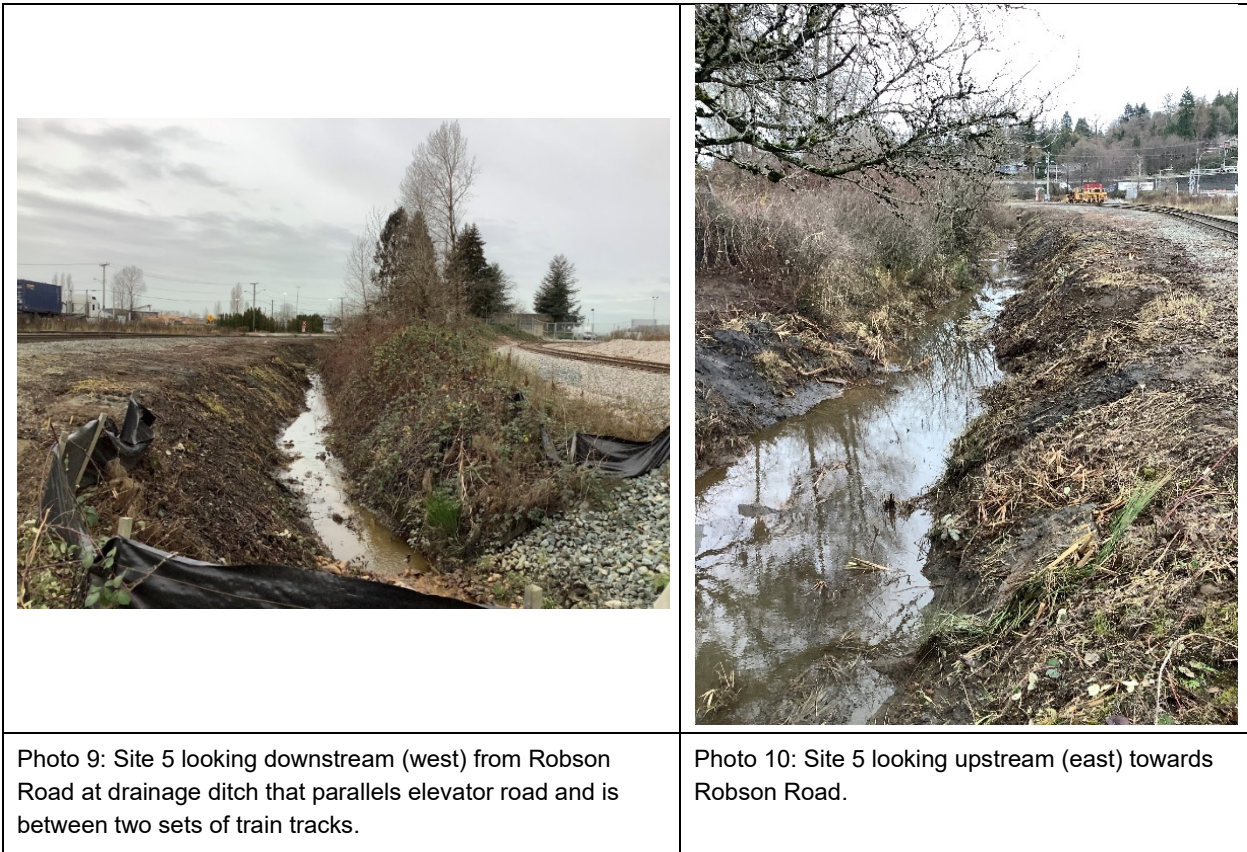
Site 6 is a 358 m long drainage ditch between Robson Road and the railroad tracks (Photo 11) that drains south and crosses Robson Street via a small concrete culvert (diameter 320 mm) to outlet into Site 5.

Photo 11: Site 6, looking downstream (south) towards Elevator Road at section of drainage ditch between train tracks and Robson Road.

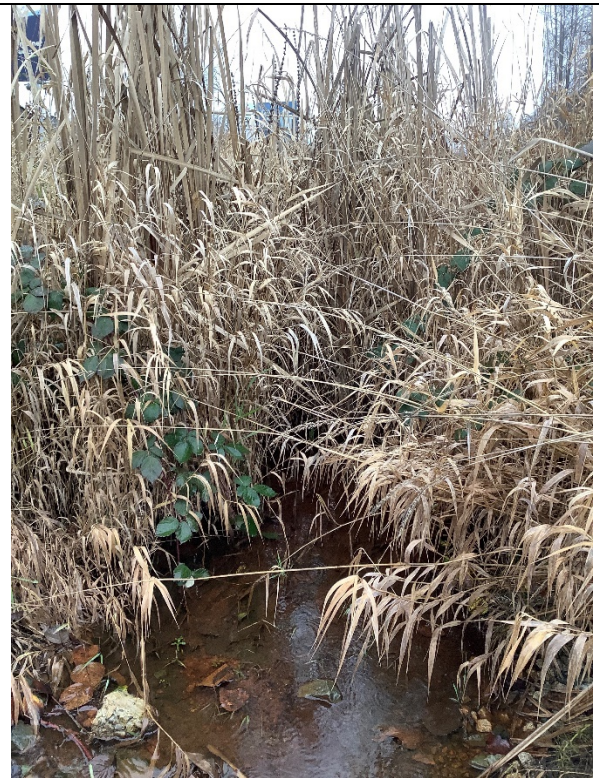
Only the culvert inlet at the south end has a defined channel (Photo 12), the rest of the ditch is wetted area with no defined channel or scour observed. No culvert was observed at the north end of ditch. At the channel inlet the channel width is approximately 1.9 m with a wetted width of 1.10 m and a residual pool depth of 0.16 m. The dominant and subdominant substrate near the inlet is fines. There are some cobbles near the inlet (likely riprap). The banks are sloped and composed of fines or organics. The riparian vegetation is reeds/cattails and grasses.

Photo 12: Looking upstream (north) at small section of defined channel prior to culvert.

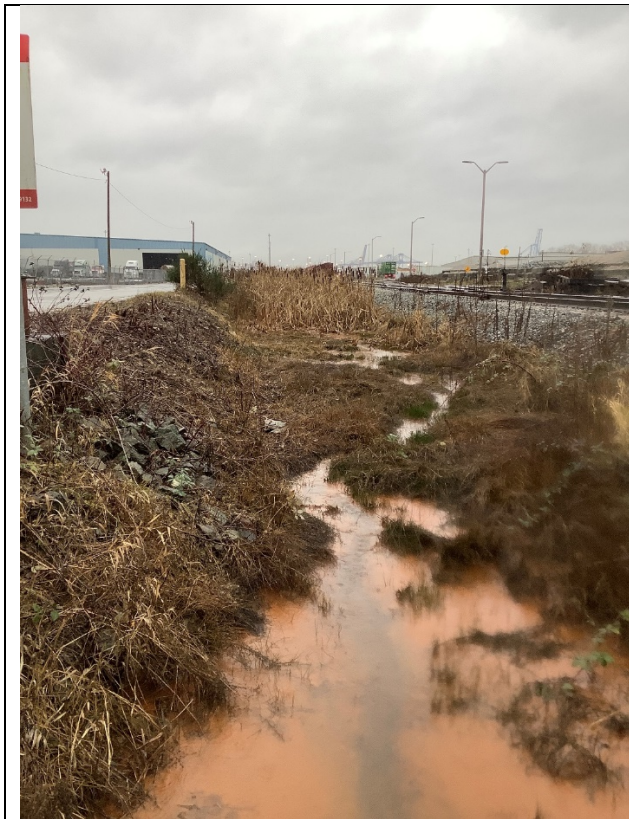
The stream channel at the outlet and inlet of the culvert were measured but the rest of the ditch (south-west) is wetted area with no defined channel. Channel width was 0.70 m with a wetted width of 0.57 m and a residual pool depth of 0.02 m. The dominant and subdominant substrate was fines and dominant cover for fish was overhanging vegetation. The banks are sloped and composed of fines. The channel outlet prior to Manson Canal is made up of road grade gravels and there are two small vertical drops of 0.10 and 0.15 m high before flowing into Manson Canal. Riparian vegetation is grass and shrubs and may be periodically maintained at the edge. Further south, vegetation is reeds (cattails), grasses, Himalayan blackberry and scotch broom. The upstream end of the ditch is vegetated and has limited scour before it becomes more inundated with water as it travels towards the Timberland Wye intersection.

Photo 13: Site 7 Looking upstream (south) from Timberland Road South and train tracks.

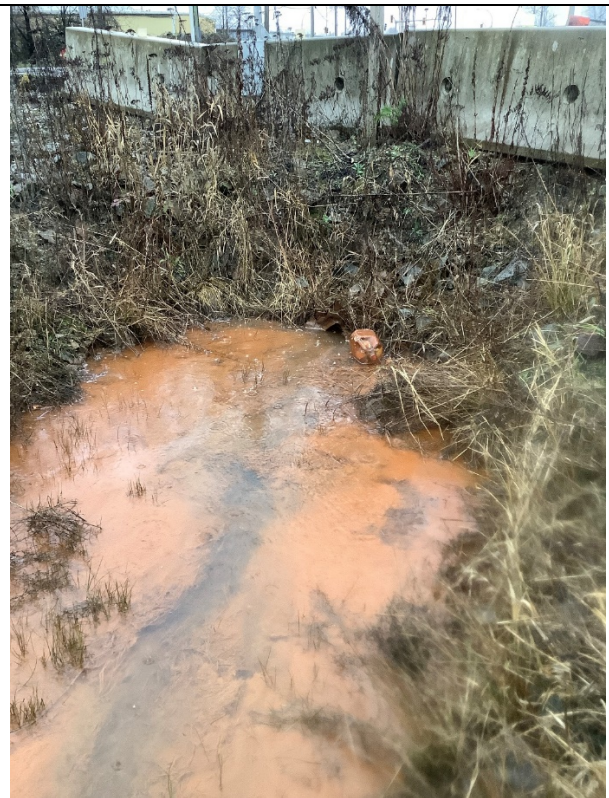
Photo 14: Looking downstream (north) at collapsed metal culvert under Timberland Wye intersection.

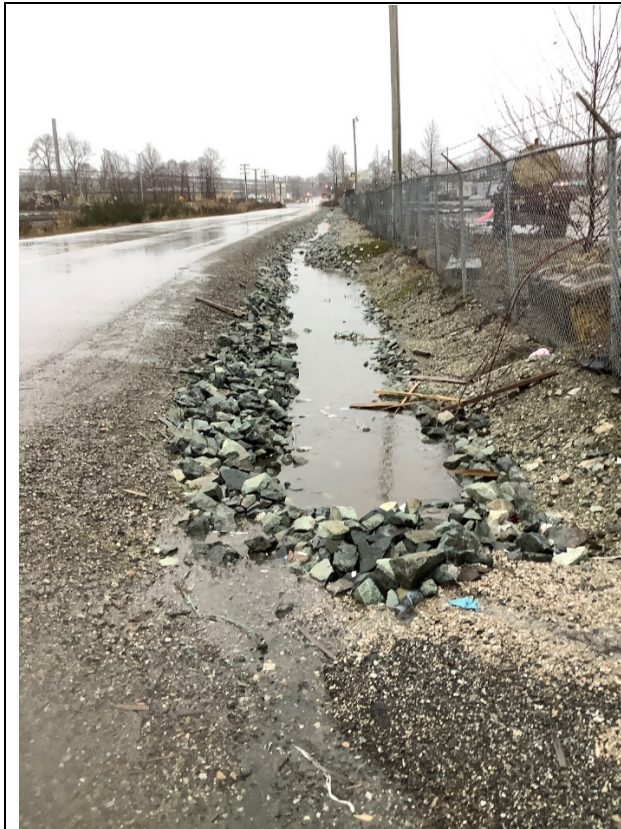
Site 8 is a 158 m long drainage ditch between the Westran property and Timberland Road South (Photo 15). Water is collected on pavement surface (Photo 16) and collects into a ditch that flows next to the road. The water flows north east to a concrete culvert partially buried under debris near the Timberland Wye intersection. The culvert likely ties into the drainage for Site 7 and flows into Manson Canal.

Photo 15: Site 8 looking downstream (north) at drainage ditch between Westran property and Timberland Road South.

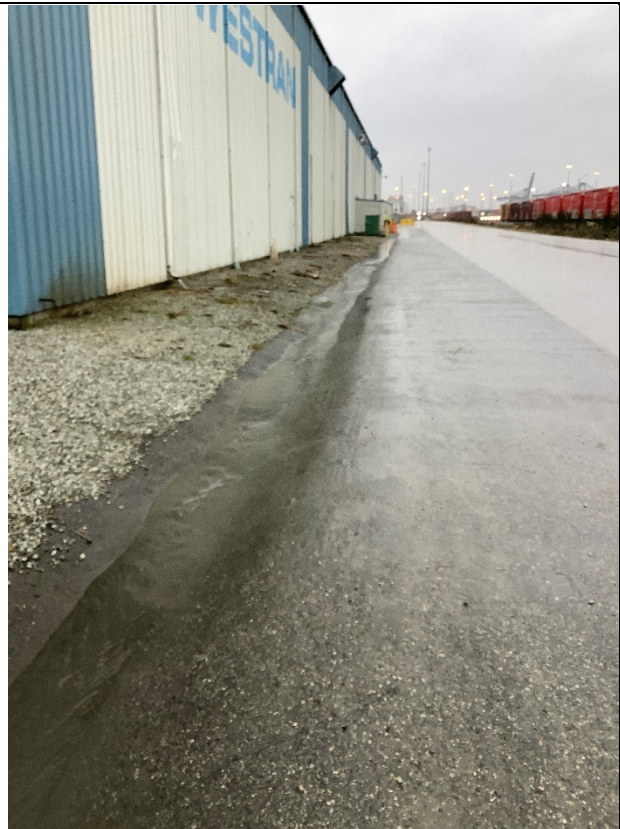
Photo 16: Site 8 looking upstream at pavement ditch collecting surface runoff.

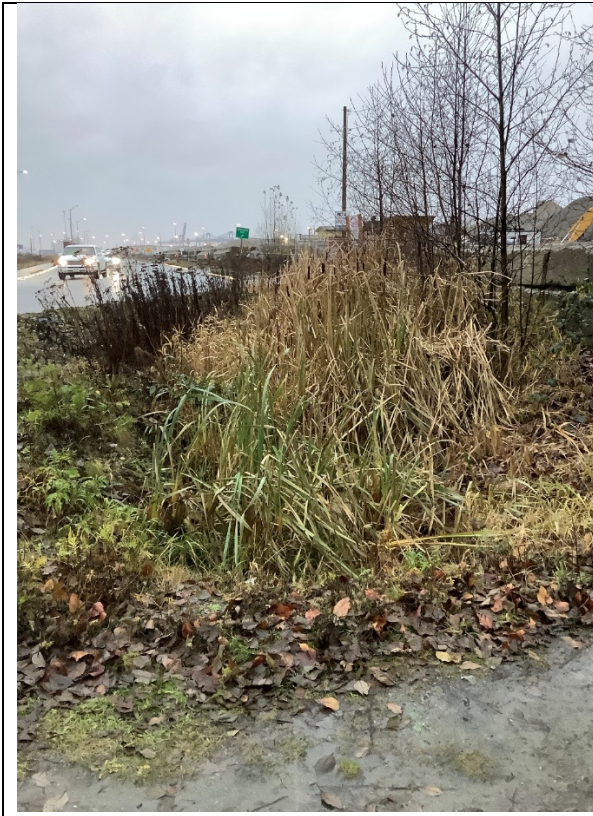
The mean channel width was 1.25 m and the wetted width was 0.88 m with a residual pool depth of 0.13 m. The dominant and subdominant substrate was fines. The dominant cover for fish is overhanging vegetation. The banks are sloped and composed of either rip-rap or fines. The riparian vegetation consists of reeds, grasses, and shrubs including Himalayan blackberry.

Photo 17: Site 9 looking upstream (south) at the North Ditch along Timberland Road North at Timberland Wye intersection. Culvert inlet is buried under the vegetation.

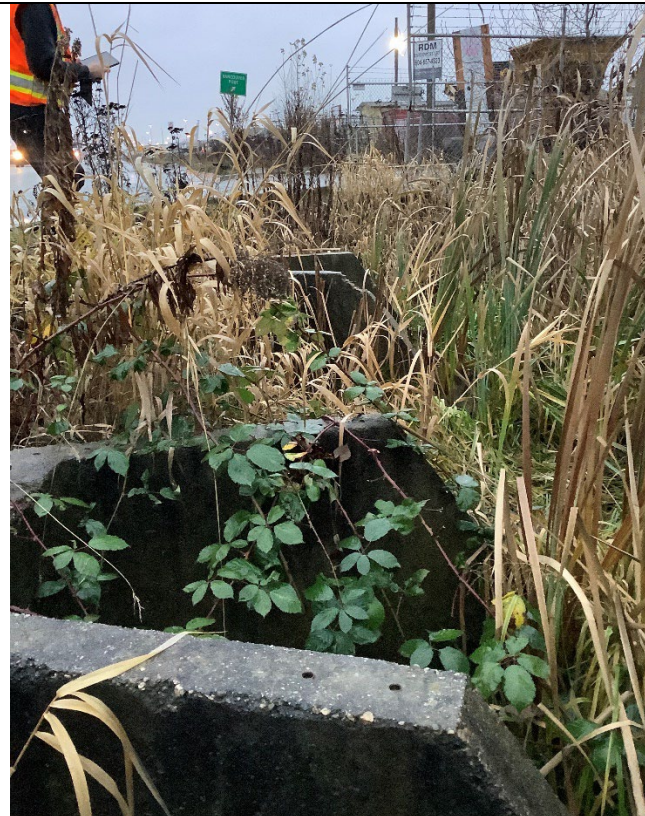
Photo 18: Site 9, looking upstream at North Ditch and two concrete outflow pipe drainages that flow into the ditch along Timberland Road North.

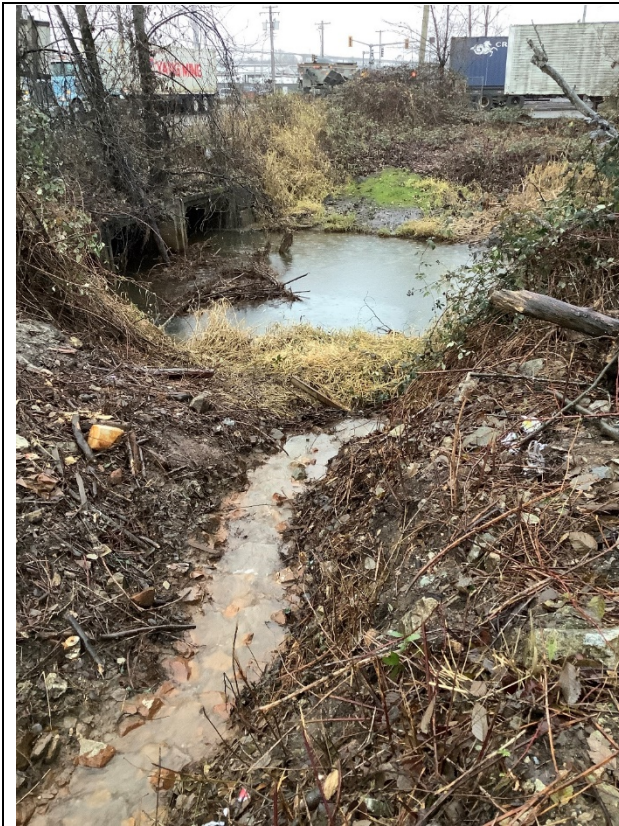
Photo 19: Site 7 and 10, looking downstream (north) at unnamed drainage that outlets into Manson Canal on the east side of Timberland Road.

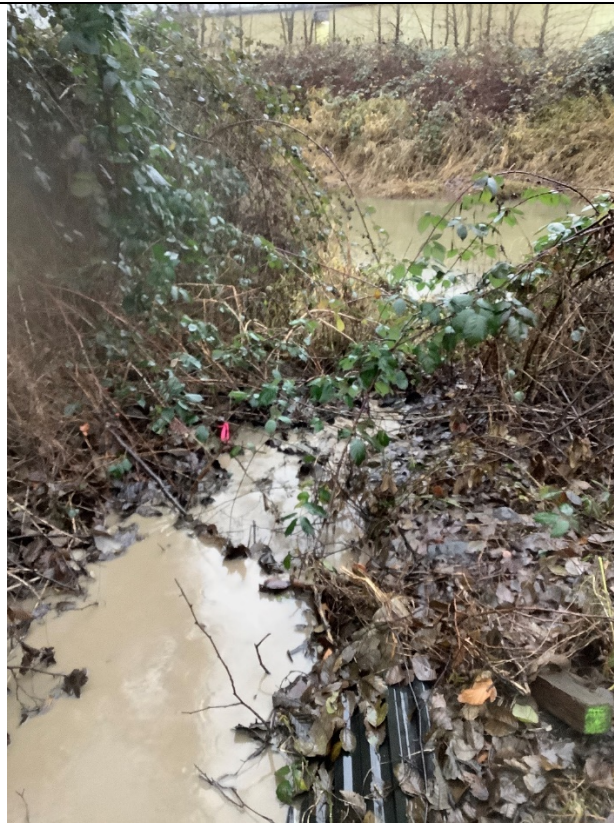
Photo 20: Site 9 and 10, looking downstream (north) at outlet to Manson Canal on the west side of Timberland Road.

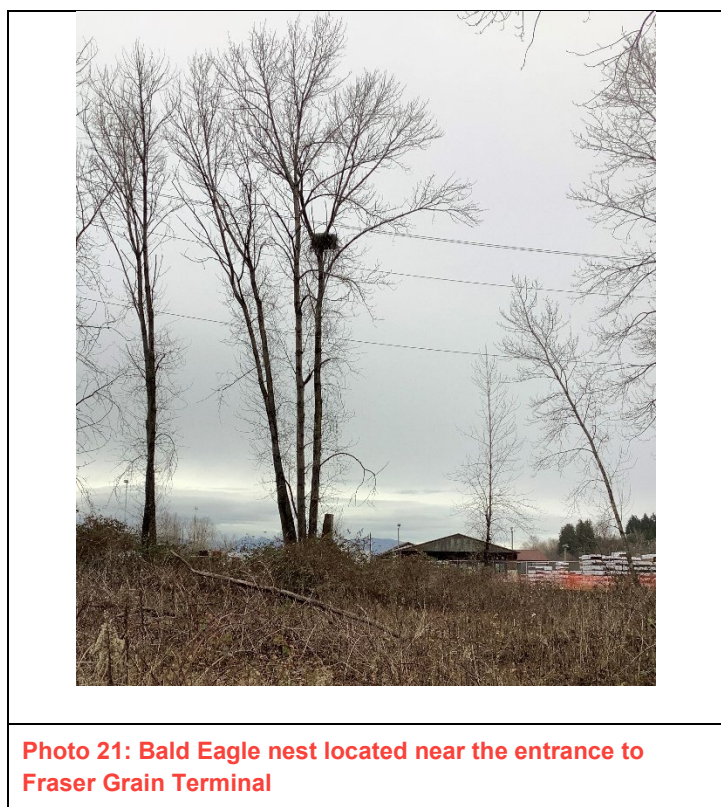
Photo 21: Bald Eagle nest located near the entrance to Fraser Grain Terminal
