VEGETATION PLAN

21780/21832/21840 South Westminster Shore & 10880 Dyke Road, Surrey

PREPARED FOR: Goodrich Group of Companies

Pacific Land Resource Group Inc.
212-12992 76 Avenue | Surrey, British Columbia | V3W 2V6 | 604-501-1624
7 June 2019 | Project #: 18-1756

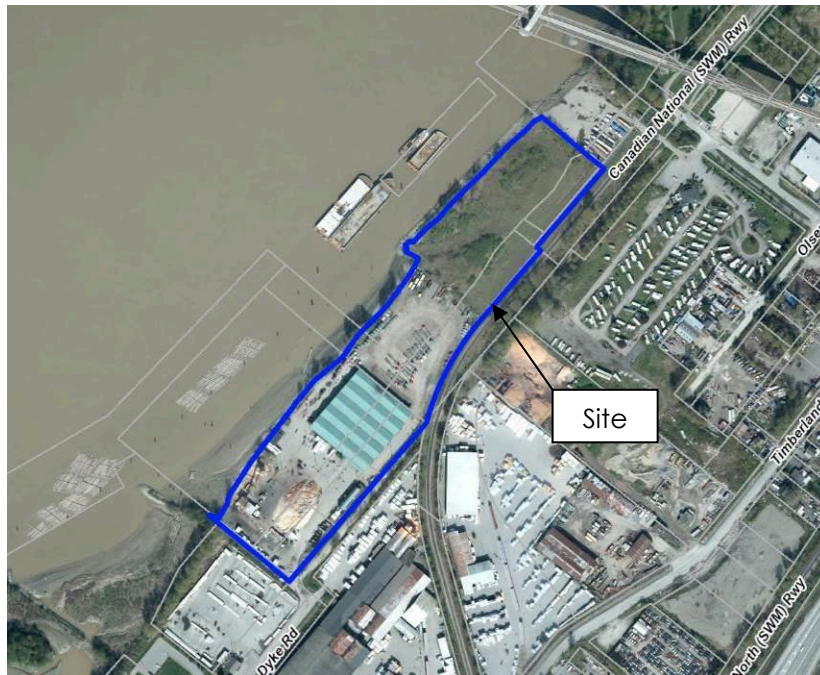
Figure 1. Area outlined in blue (i.e., Site) is proposed to be leased from the Port of Vancouver.

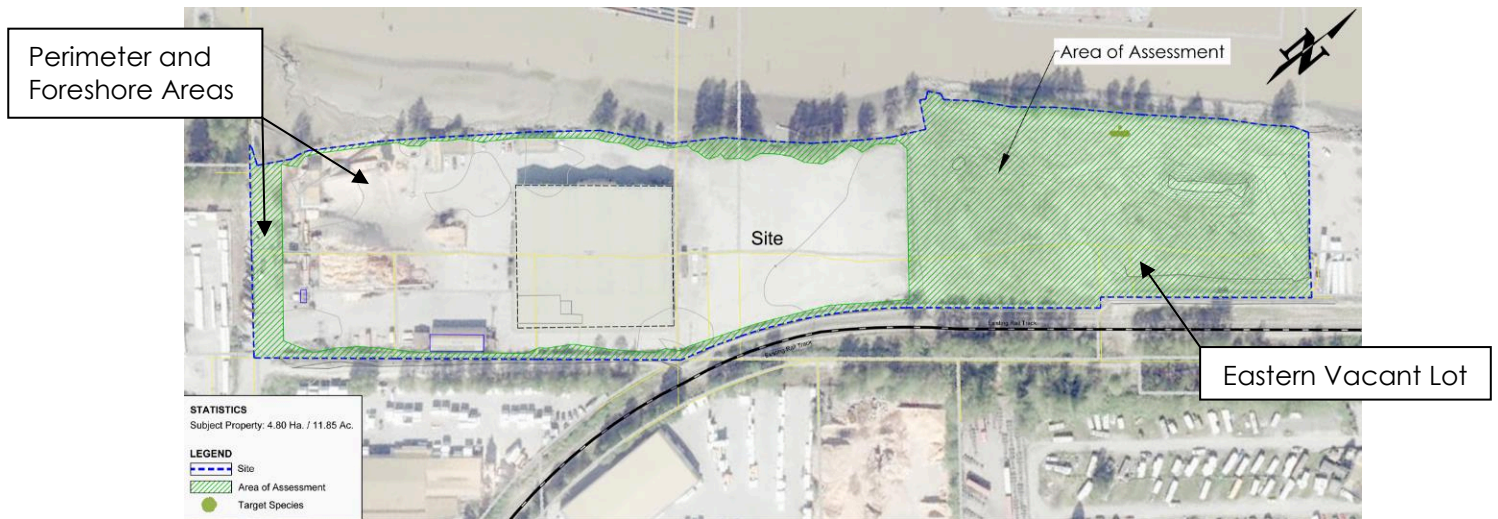
Figure 2. COSMOS aerial of the Site (dashed blue line), showing the area of assessment (green hatched areas) evaluated during PLG's Site visits.

The scope of this VP includes an assessment of the Site, in its entirety, addresses existing invasive plant populations within the Site, concentrated within two areas: PFA and EVL (refer to Figure 2, above and attached).

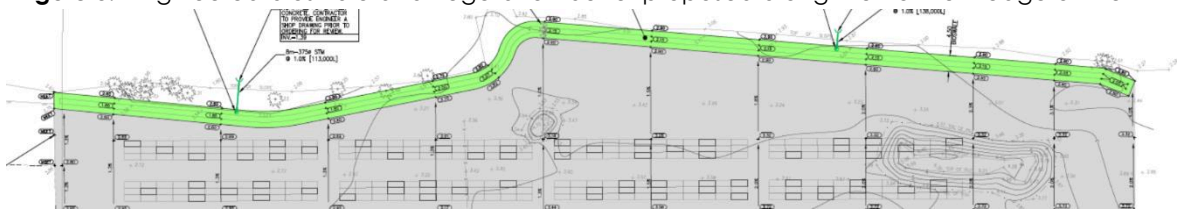
Figure 4. Bioswale design includes the retention of mature trees, located north of the EVL
