**Review of Environmental Conditions / Updated Groundwater Quality Investigation
10880 Dyke Road, Surrey, BC**

Supplemental Site Investigation Surrey Brownsville Site (Lots 2, 3, 4, 5, 6) Surrey, BC

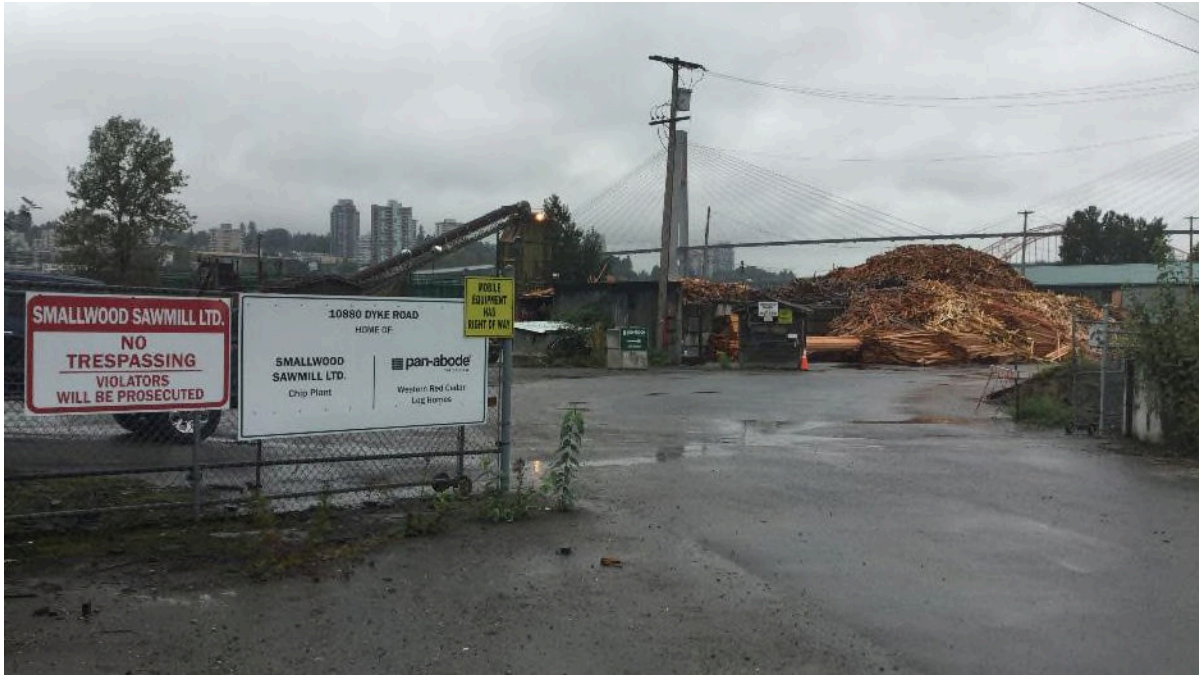
Photo 1: Entrance to the Smallwood Sawmill site and weather conditions at time of sampling

Date: September 11, 2018 | **Facing:** North

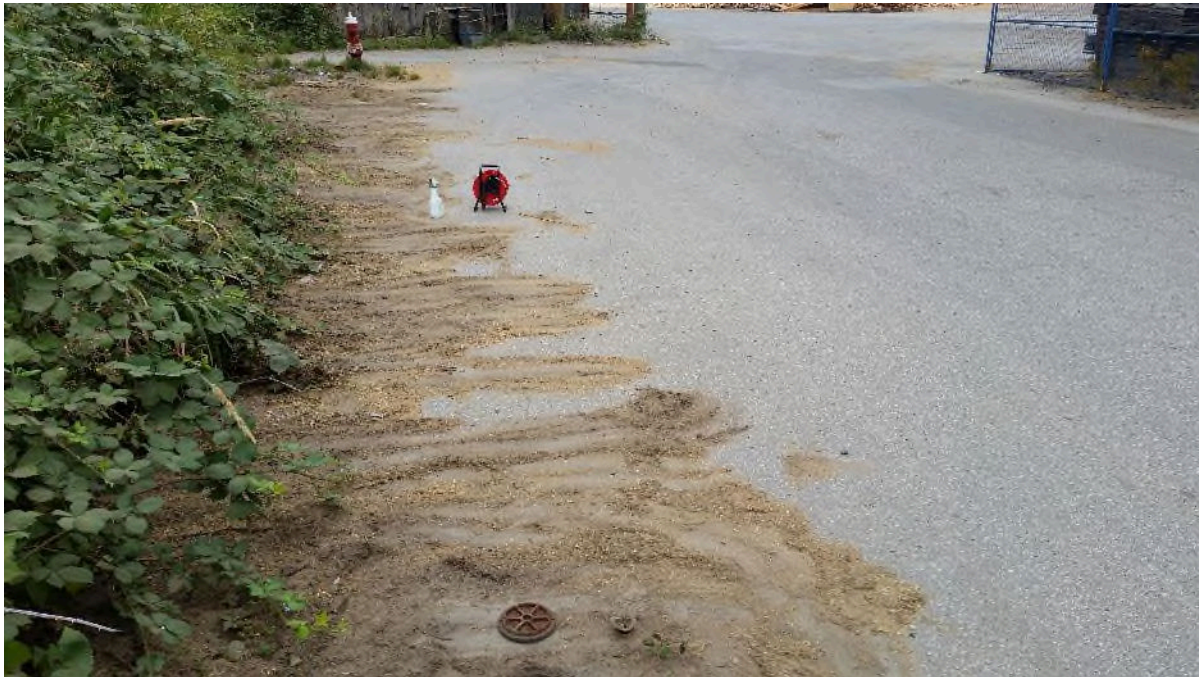
Photo 2: General locations of the monitoring wells south of the distribution warehouse, as seen during a preliminary site visit.

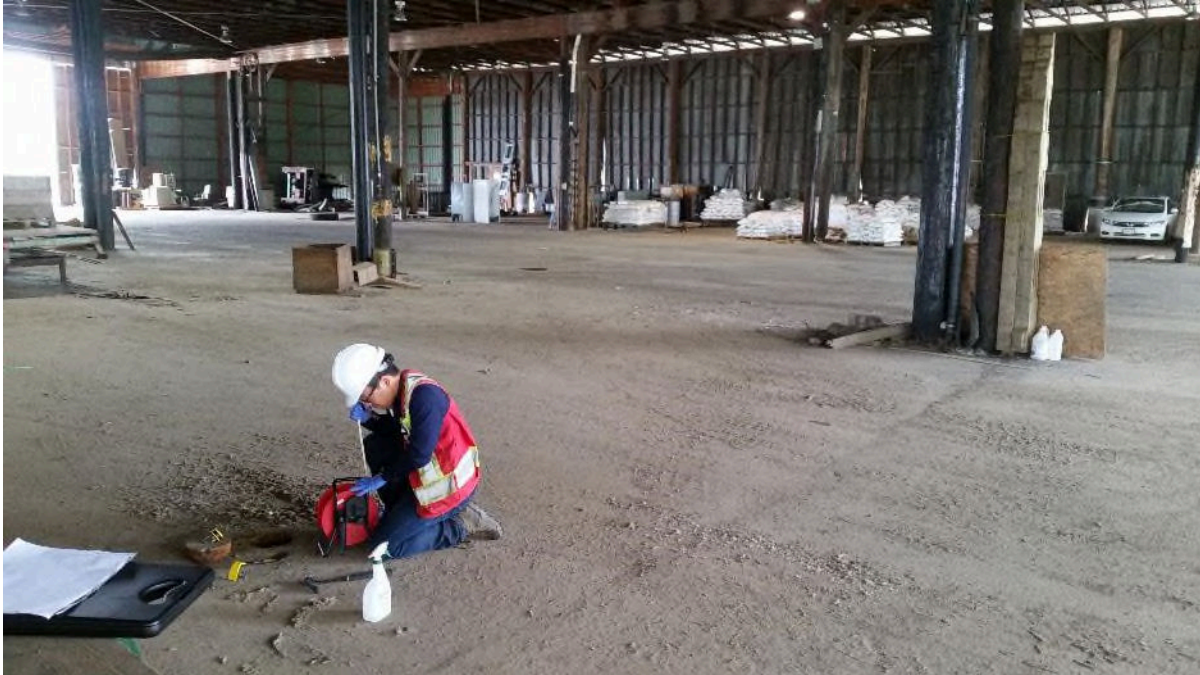
Photo 3: Checking the depth to groundwater on MW08-11 during the preliminary site visit.

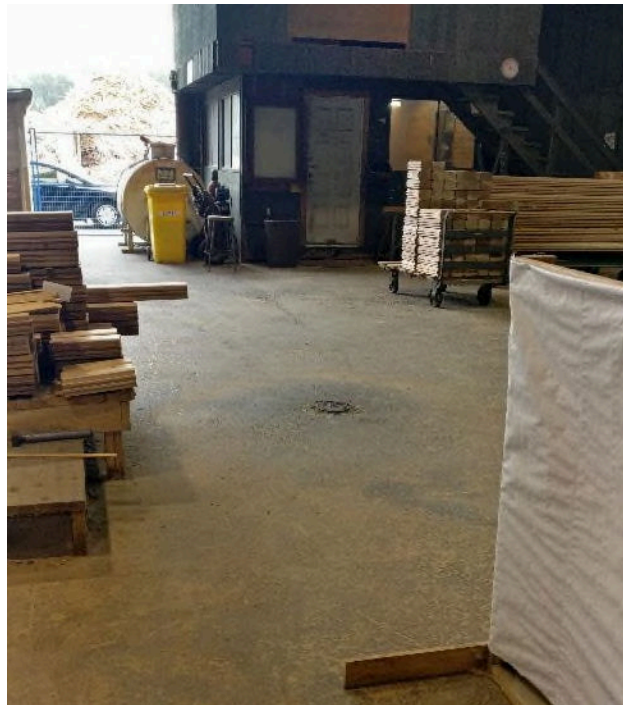
Photo 4: Location of MW08-10 within the distribution warehouse.

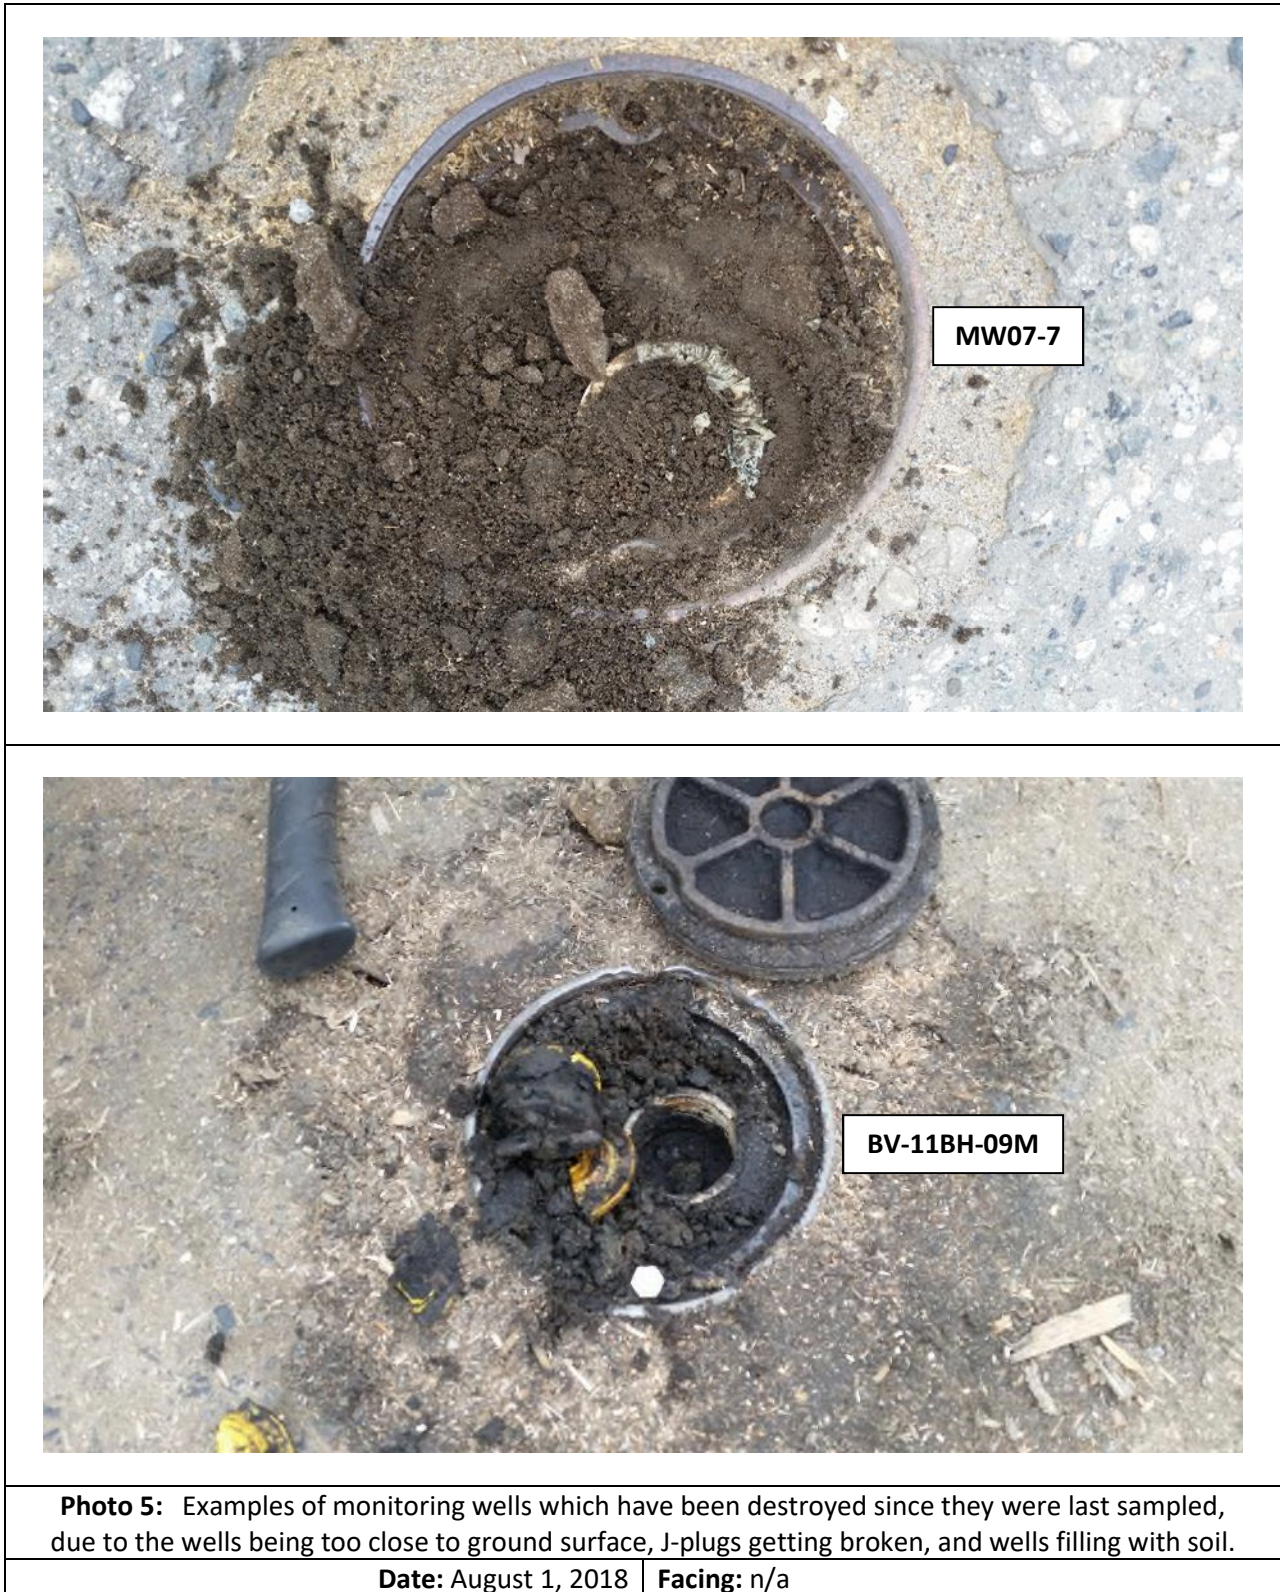
Photo 5: Examples of monitoring wells which have been destroyed since they were last sampled, due to the wells being too close to ground surface, J-plugs getting broken, and wells filling with soil.

At the other APECs, it was difficult to assess trends in groundwater quality as many of the previous monitoring wells could not be found to be re-sampled (likely buried or removed by the previous tenant) or had not been sampled for dissolved metals in the past. Based on the latest groundwater data at the other APECs, there does not appear to be sufficient evidence to warrant identification of any of those APECs as AECs. The reported dissolved metals concentrations which exceed the applied criteria (dissolved aluminum, dissolved arsenic, dissolved titanium, dissolved zinc) are not believed to be related to historical site activities, as previously stated by Envirochem and others.

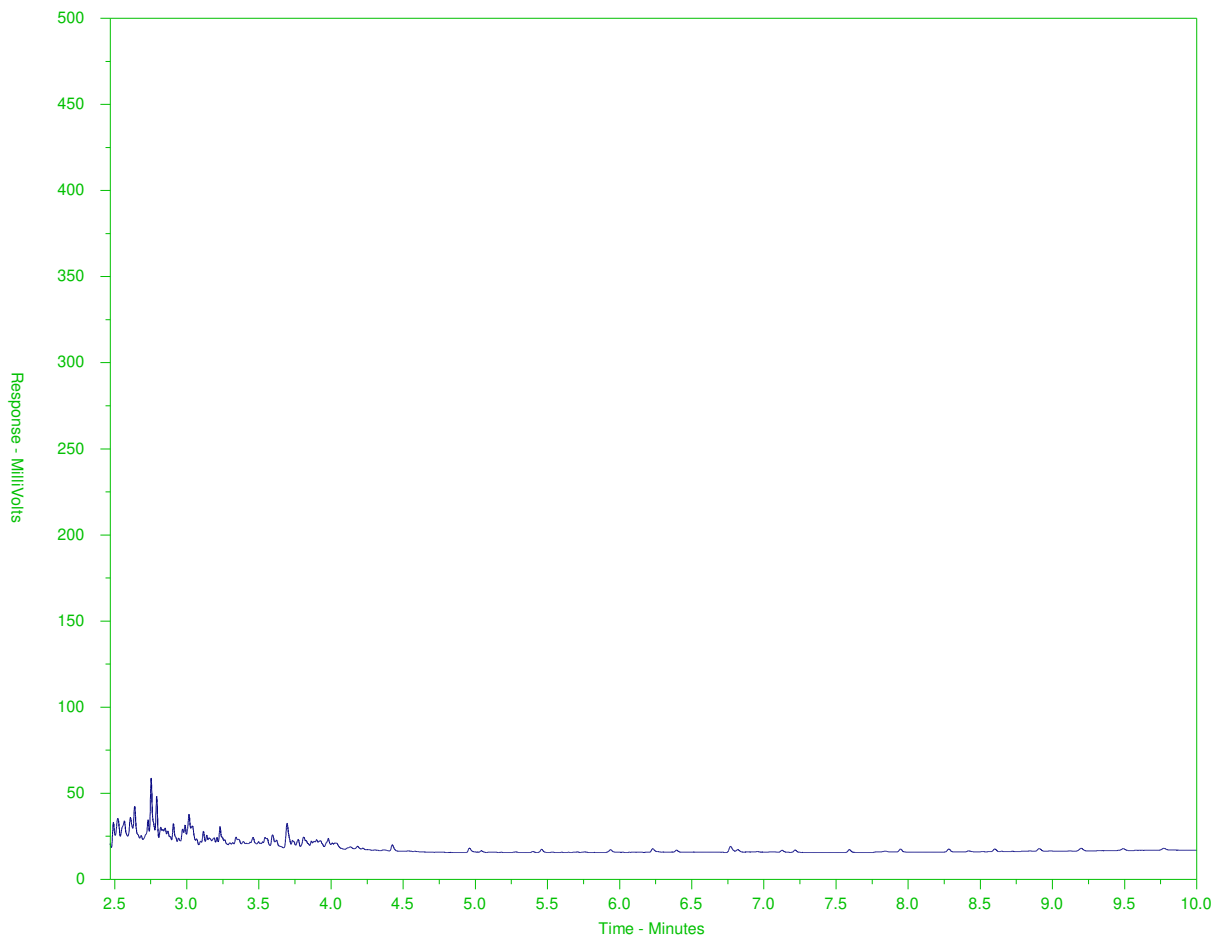
ALS Sample ID: L2162381-2
 Client Sample ID: MW07-6

← EPH10-19 →		← EPH19-32 →	
nC10	nC19	nC32	
174°C	330°C	467°C	
346°F	626°F	873°F	
← Gasoline →		← Motor Oils/ Lube Oils/ Grease →	
← Diesel/ Jet Fuels →

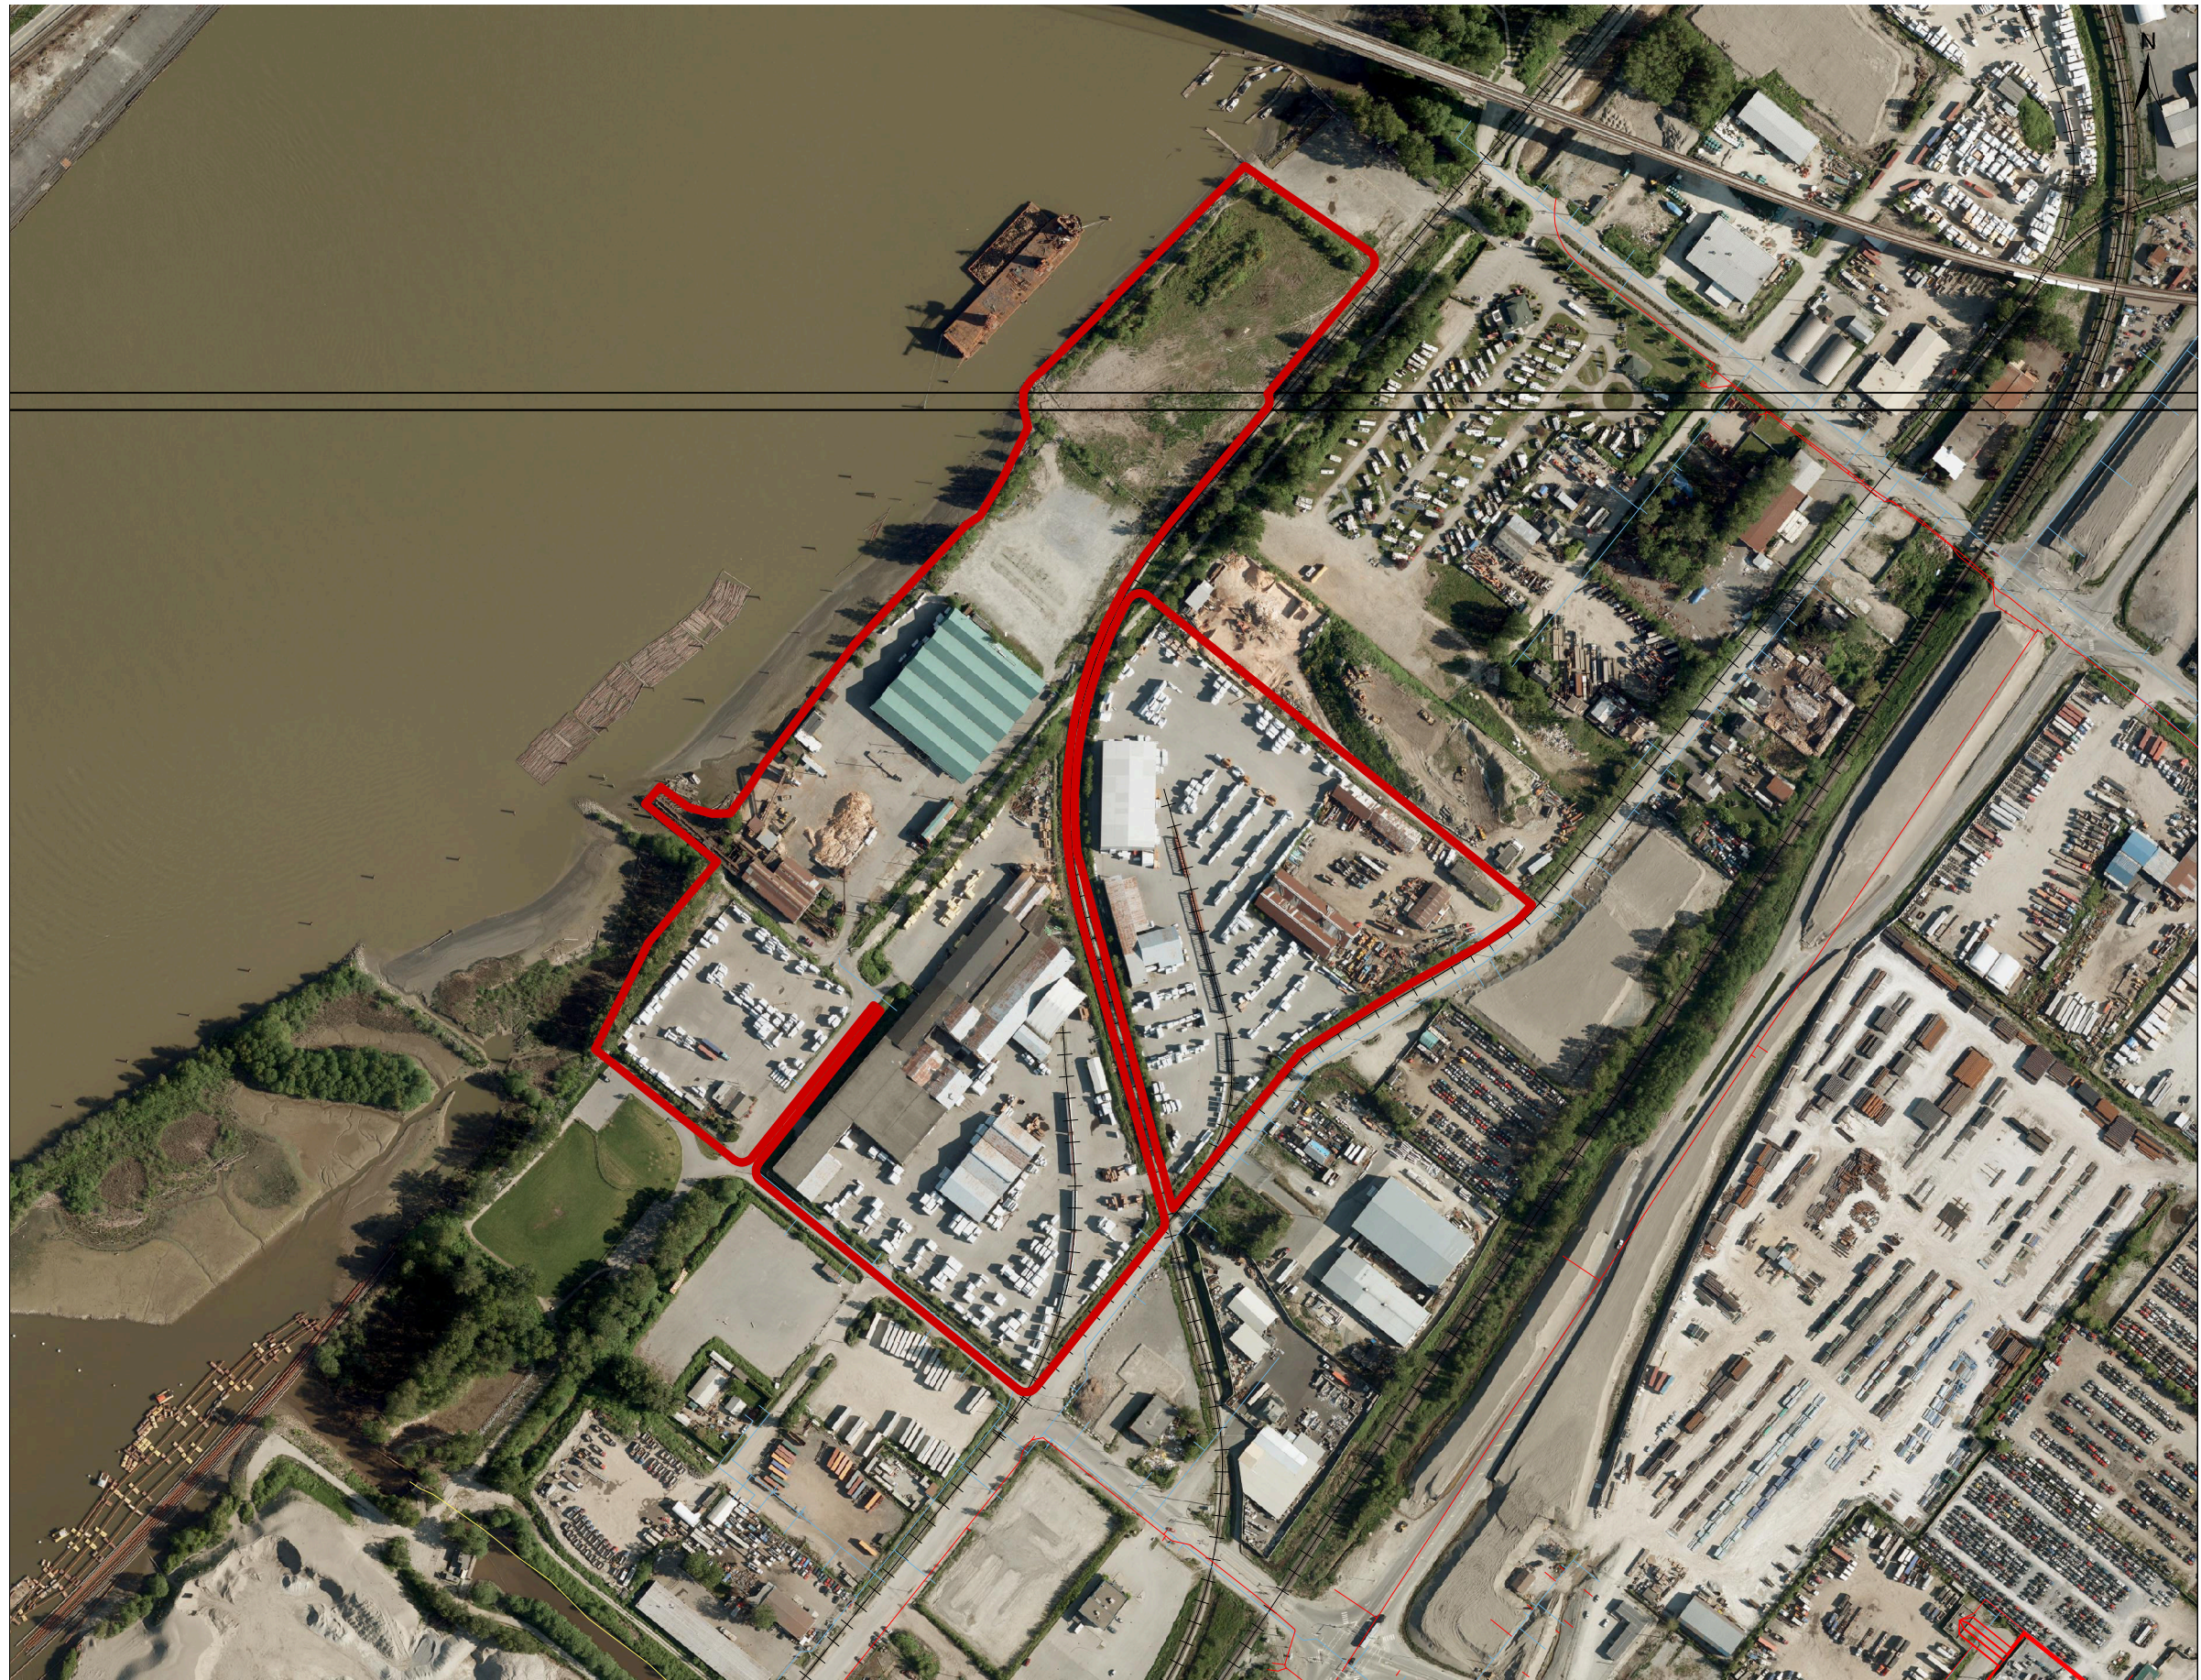
Date: **APRIL 2012**
FIGURE 1

The Site is located in Surrey, BC, approximately 0.5km southwest of the Pattullo Bridge. The Site is situated on the east banks of the Fraser River and covers an area of approximately 16.2 ha (Figure 1).
