**CONTAMINATION ARISING FROM THIRD-PARTY SOURCES
INDEPENDENT OF MILL & TIMBER PRODUCTS LTD.
10880 DYKE ROAD, SURREY, BC**

Prepared for:
Mill & Timber Products Ltd.

Prepared by:
Envirochem Services Inc.

March 2019

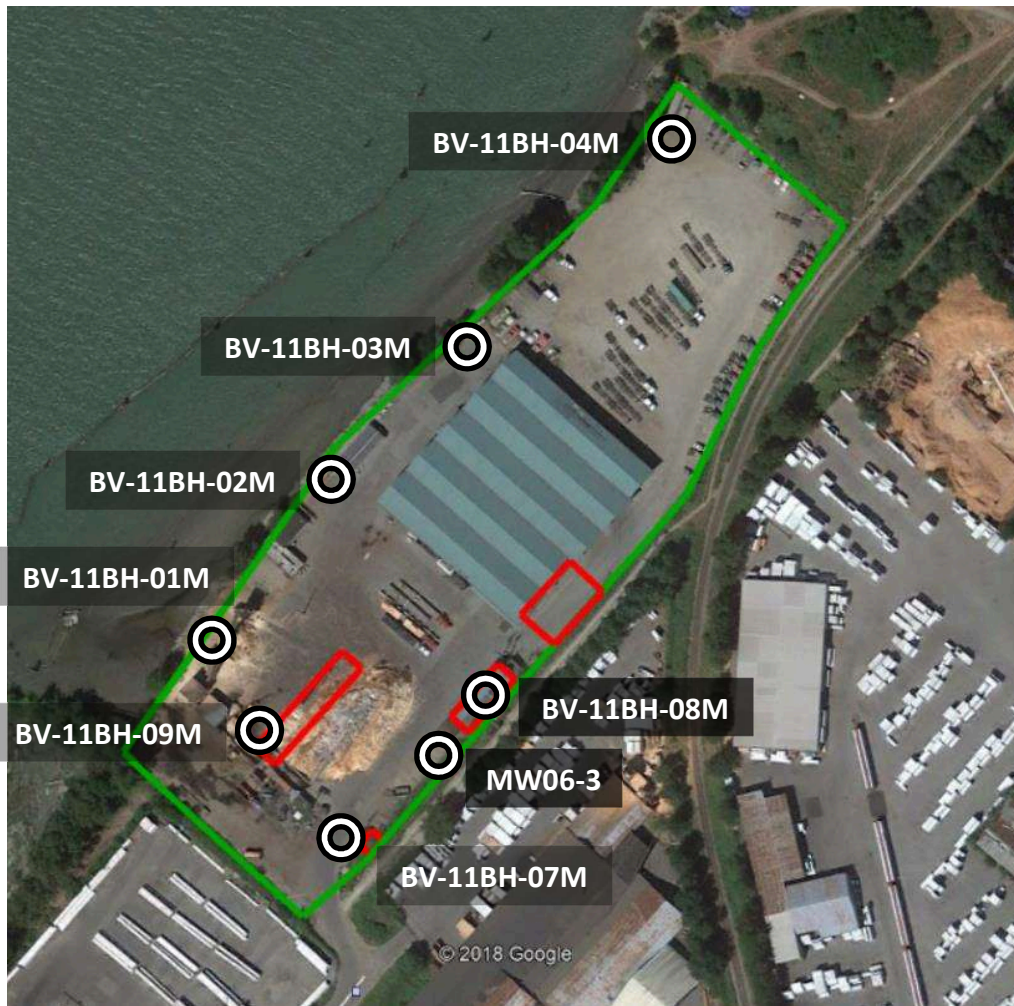
Borehole and Monitoring Well Locations (Google Earth, 2017 Aerial Photo)

Following completion of the SSI report in 2013, it does not appear the Franz Environmental had any further involvement at the Site. The included figures below show the approximate locations of the boreholes and monitoring wells advanced by Hemmera and Franz for their investigations.

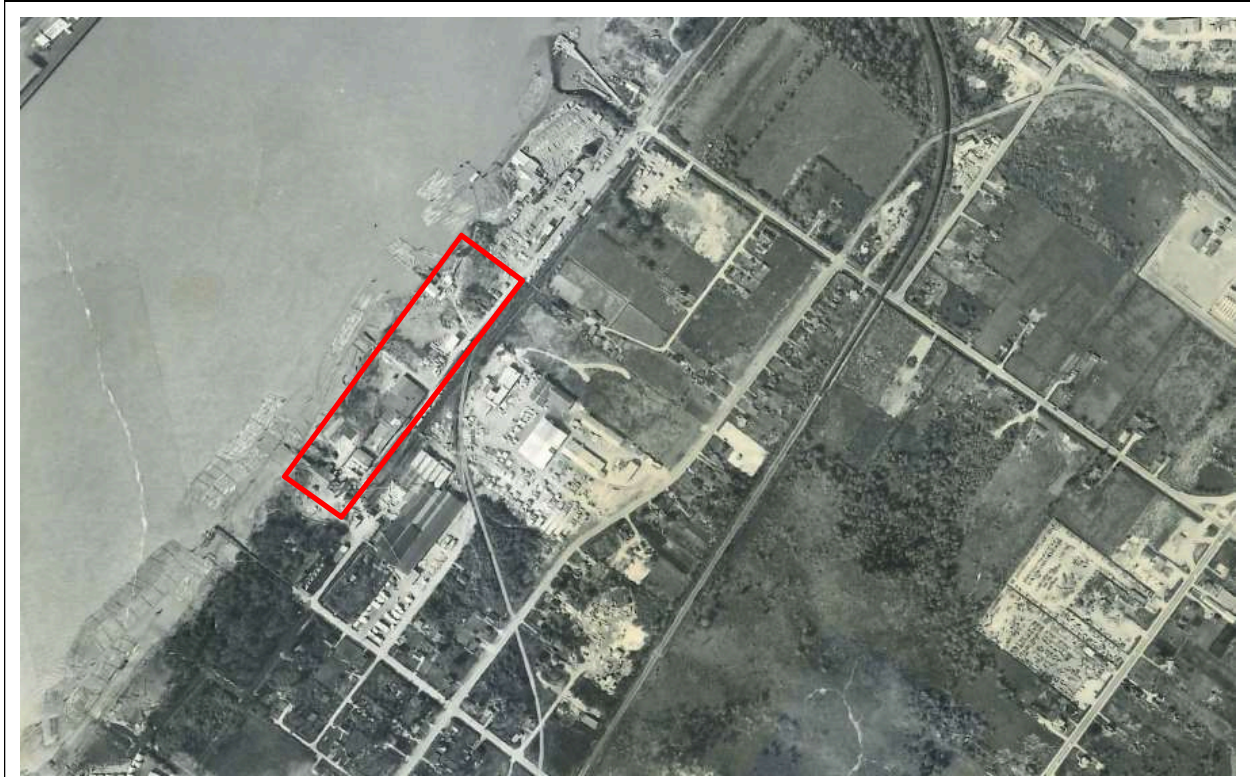
Aerial Photo 5.	The general area of the Site in 1963.	Source: UBC GIC
-----------------	---------------------------------------	-----------------

Photo 5 Zoom	Close-up of suspect aboveground storage tank (AST) in vicinity of APEC #34 (AEC-1) in 1963.	Source: UBC GIC
--------------	---	-----------------

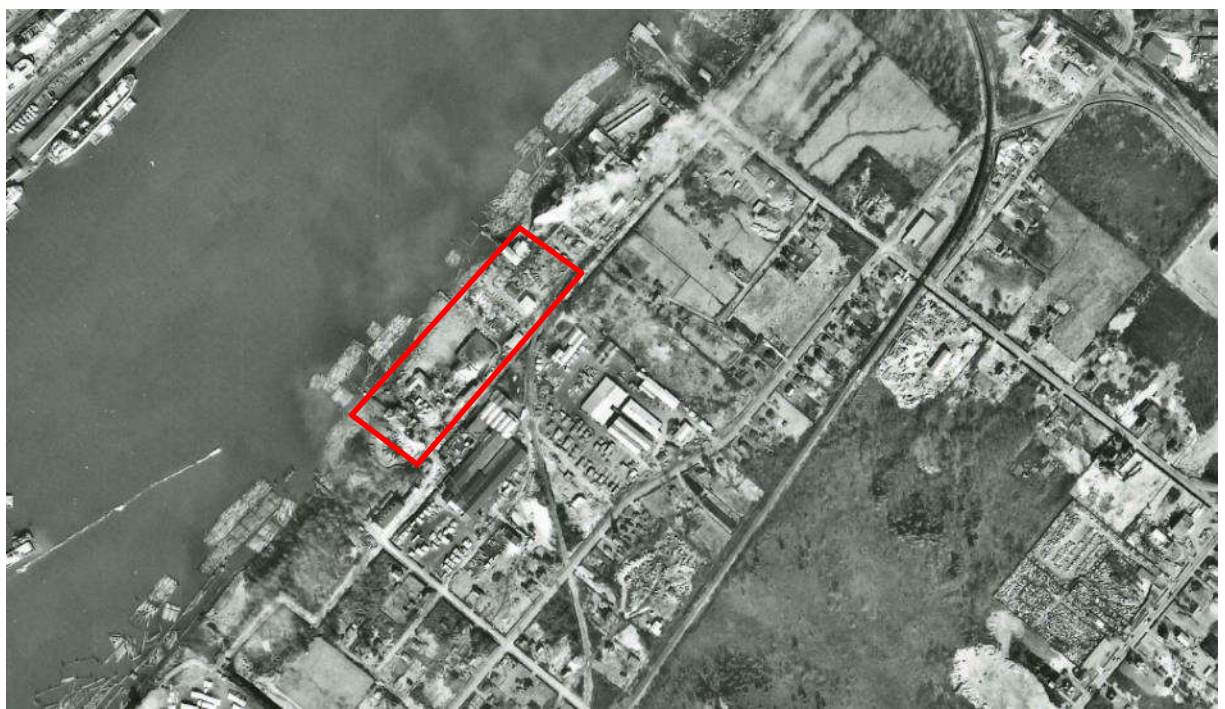
Aerial Photo 6.	The general area of the Site in 1969.	Source: UBC GIC
-----------------	---------------------------------------	-----------------

Photo 6 Zoom	Close-up of suspect aboveground storage tank (AST) in vicinity of APEC #34 (AEC-1), still present in 1969.	Source: UBC GIC
--------------	--	-----------------

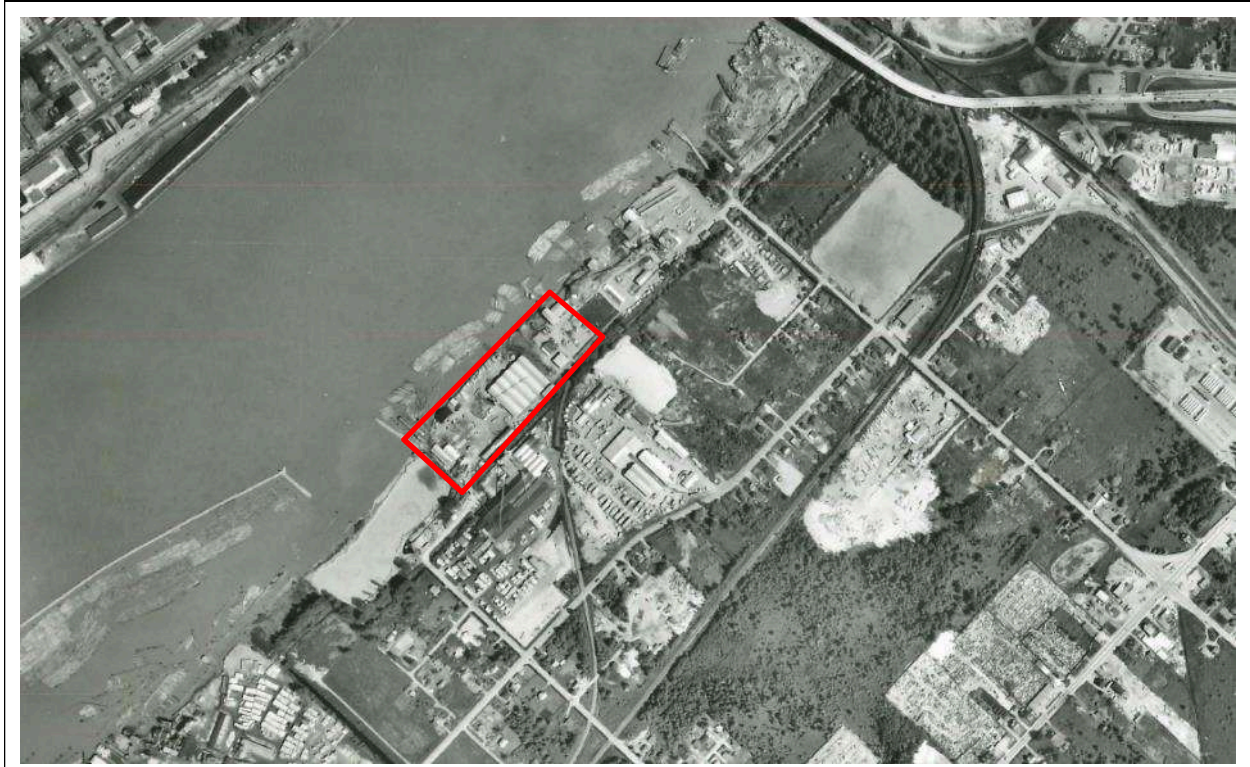
Aerial Photo 7. The general area of the Site in 1974.

Photo 7 Zoom

Suspect AST no longer present in 1974. Site layout has changed (distribution warehouse has been built).

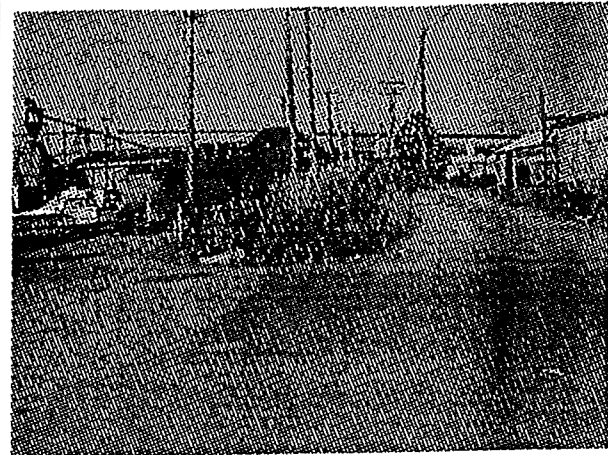
Oil staining was noted along the south side of the oil shed below the drums stored along the outside wall. In addition stained soil was evident below the elevated floor (*see the following section for further discussion on this matter*).

Oil shed and dyke looking northeast at entry road

The company stores oil and diesel fuel in a wood building located in the south east section of parcel A. It would be prudent to replace the old oil storage building with a modern one, designed for such storage, and remediate the underlying soils. If this is not done, the contamination problem will likely continue and the level of soil contamination will remain, or possibly become more serious.

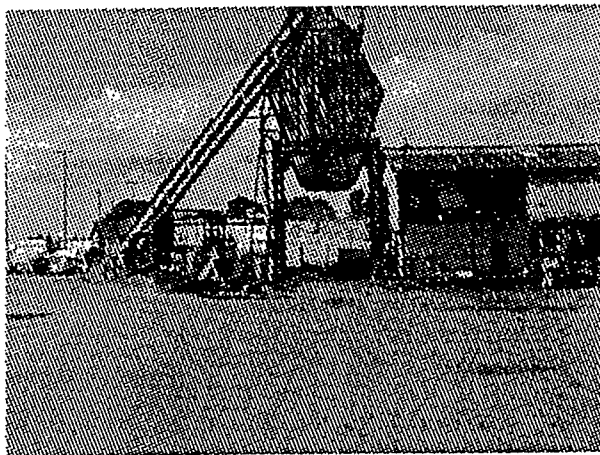
Hogfuel hopper and supply conveyer in southwest sector of parcel A

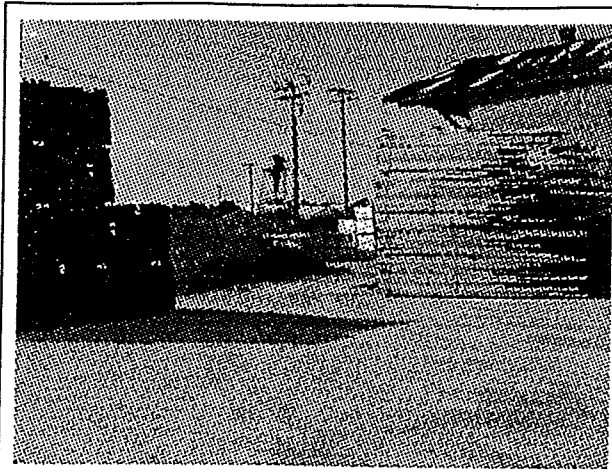
Outdoor wood storage - southeast corner of shed

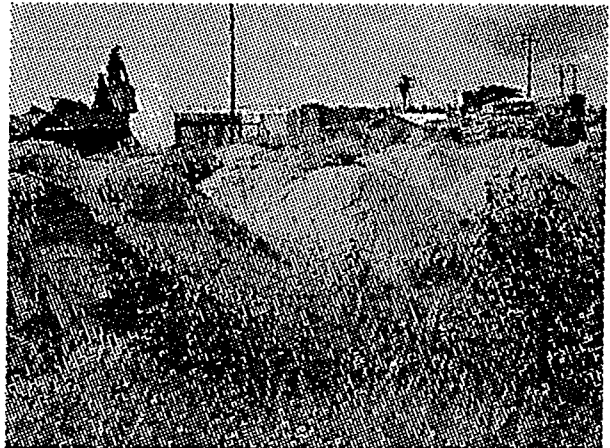
Piles of sand fill, with some metal debris were found in the central section of parcel C, just north of the beginning of the old Brownsville spur. The source of these piles could not be determined, but may have resulted from excavations during the decommissioning of the wood mill originally located here, or opportunistic disposal by local contractors. *No environmentally hazardous debris was found in the surface of these piles.*

Piles of sandy fill located in the south central sector of parcel C.
